**Fracture Critical  
Bridge Inspection Report**

**Bridge No. 2490003  
Christian County, Missouri  
Smyrna Road over Finley River**

**Prepared by H.W. Lochner, Inc.  
January 2024**

# Comprehensive Fracture Critical Bridge Inspection Report

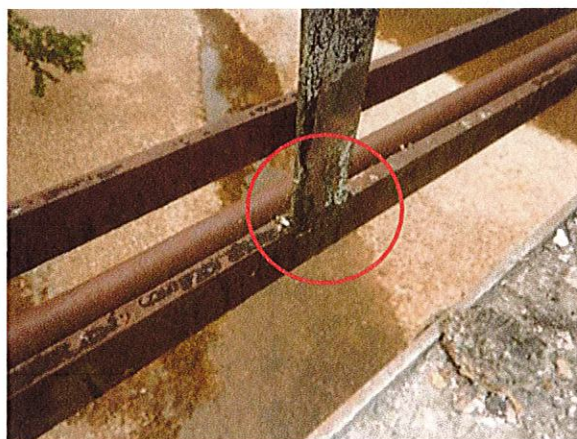
There are rail posts welded to the lower chord members and utility attachments welded to the lower chord members, which is a flawed detail (**see photo below**).

Thru Truss: Rail post welded to lower chord

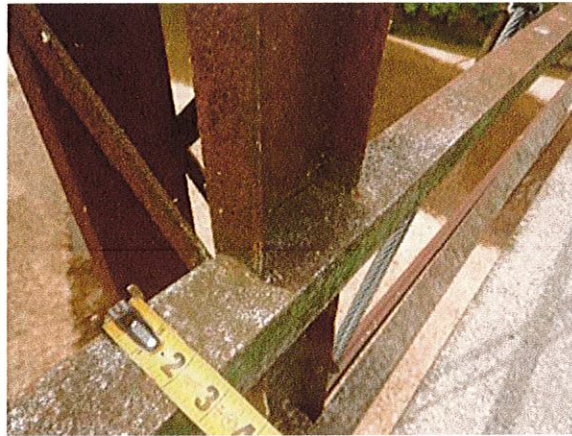
The bridge rail is welded to the verticals, which is a flawed detail (**see photo below**).

Thru Truss: Bridge rail welded to vertical

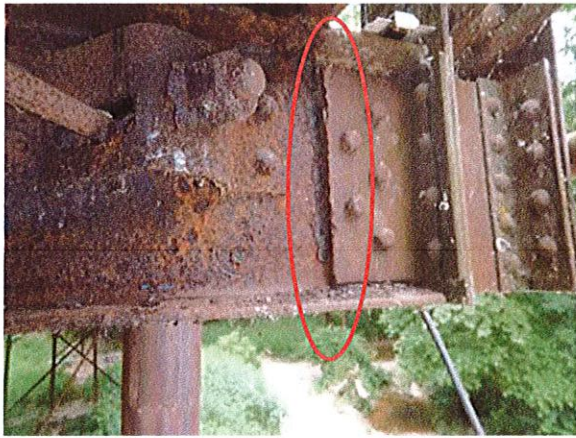
The floor beams have heavy surface rust and moderate pitting throughout. Several of the floor beams have heavy section loss at the ends of the members. The section loss is occurring on the floor beam webs at the edge of the clip angle that connects the floor beam to the vertical's hanger plates. The top and bottom flanges of several floor beams have heavy section loss within 4 ft. of each end (**see photos below**).

Due to the advanced section loss in their webs, the floor beams are considered to be in serious condition.

Floor Beam 1, East End, North Face:  
Serious section loss in web next to  
connection plate

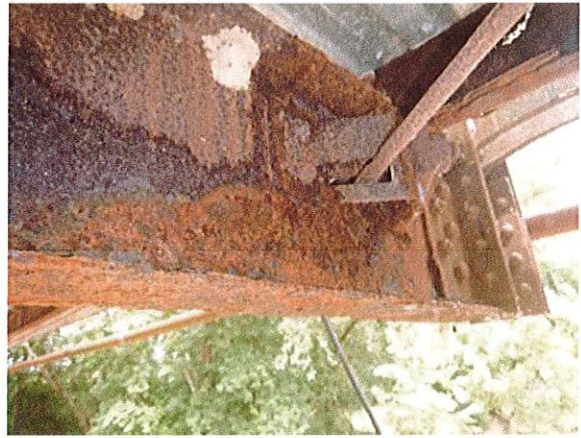
Floor Beam 3, East End: 40% section loss  
to bottom flange

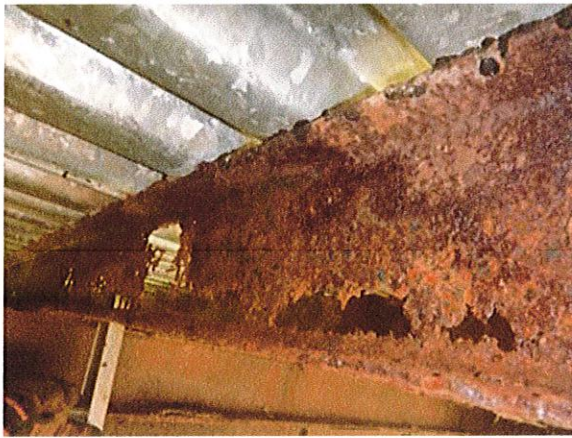
- **Stringer No. 4: 100% section loss to web at north end of member**
- **Stringer No. 5: 50% section loss in member for full length**

Span 3, Panel 1, Stringer No. 4: Large holes  
rusted thru web

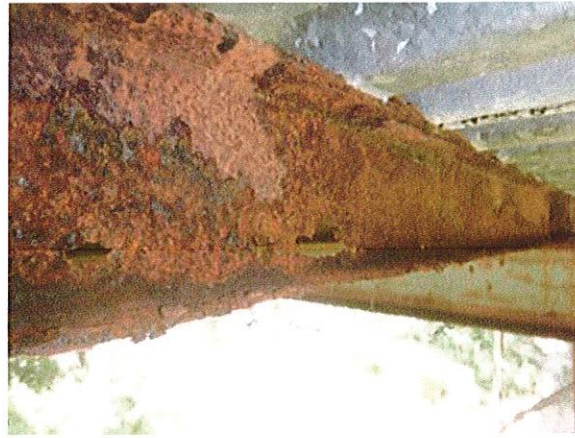
Span 2, Panels 3 and 4, Stringer No. 4:  
80% section loss to web and bottom flange

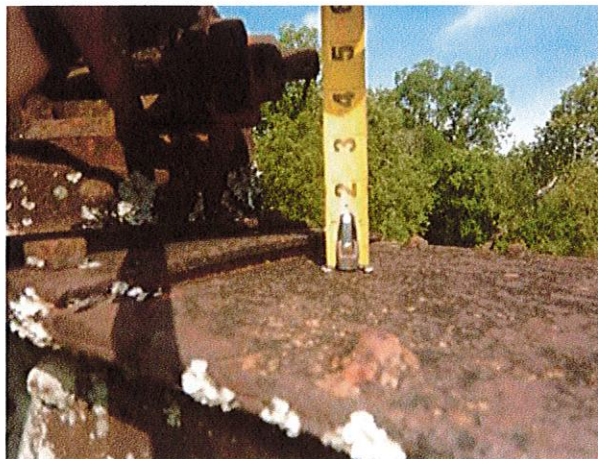
The upper chord is in fair condition overall. The upper chord members have heavy surface rusting and minor pitting throughout. There is minor to moderate pack rust jacking between the top chord and the lateral strut connection plate (**see photo below**). There is minor rippling in the top chord between the top cover plate and the channel members.

Thru Truss, West Truss: Minor pack rust jacking between upper chord and lateral strut connection plate

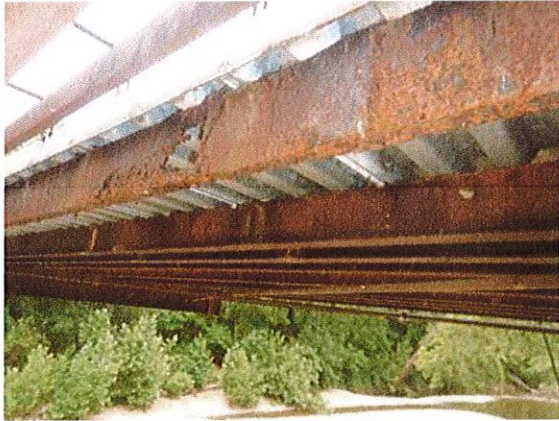
**The majority of the exterior stringers (Stringer Nos. 1 and 9) are in serious condition due to extensive section loss.**

Span 4, Panel 3, Stringer No. 1: 100% section loss to web, serious section loss to flanges

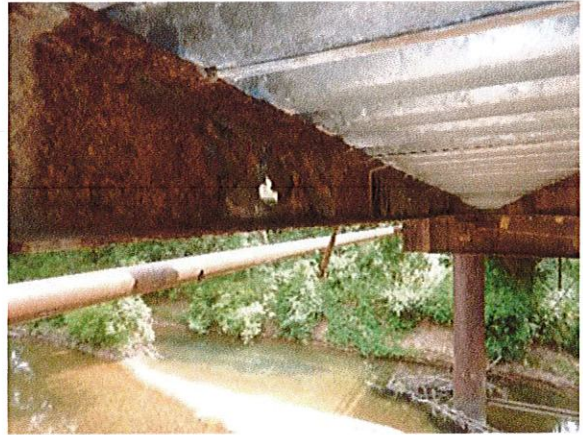
Span 4, Panel 5, Stringer No. 1: heavy pack rust and serious section loss to stringer

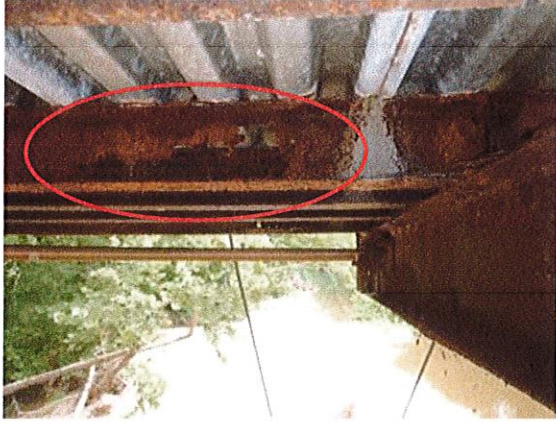
Span 4, Panel 3, Stringer No. 4: Web rusted out near south end

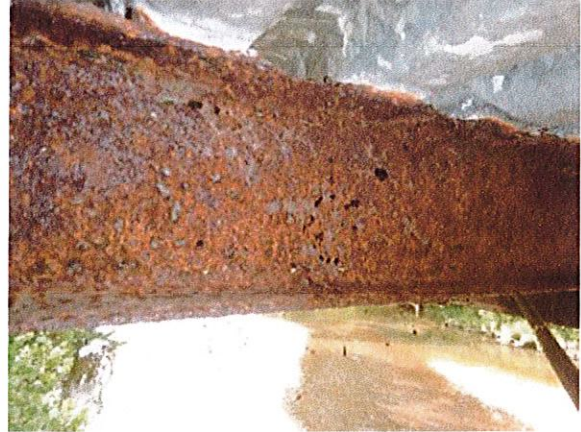
Span 4, Panel 7, Stringer No. 6: 80% section loss to web, 3/16" flange thickness remaining

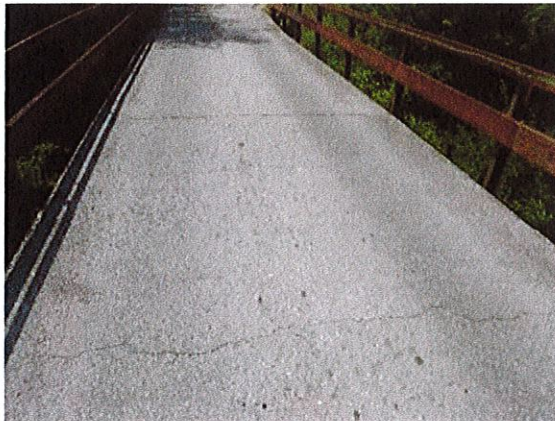
The deck is comprised of corrugated metal stay-in-place forms topped with asphalt. The deck is in good condition overall. The corrugated metal is in good condition with small pockets of minor rust at some of the seams. The asphalt surface has minor to moderate cracking.

Typical asphalt deck surface

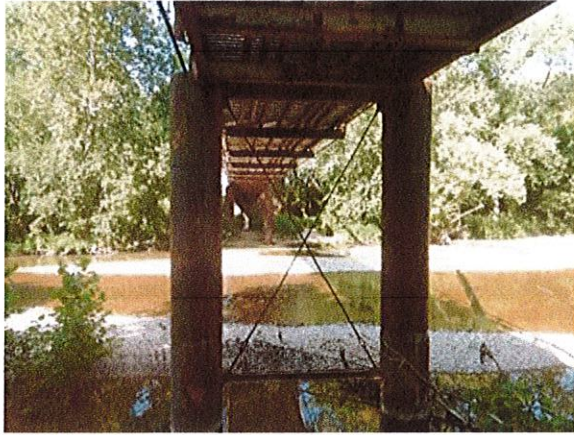
Intermediate Bent 4 and Bent 5 support the main thru truss span and are comprised of two steel caissons filled with concrete. These piers are in satisfactory condition overall.

Bent 5  
(Bent 4 is similar)

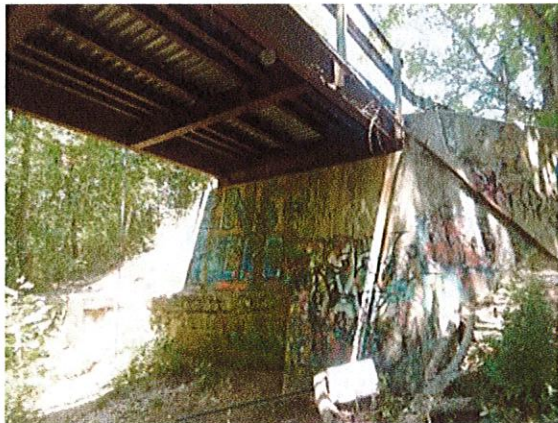
Bent 1 (north abutment): Satisfactory condition

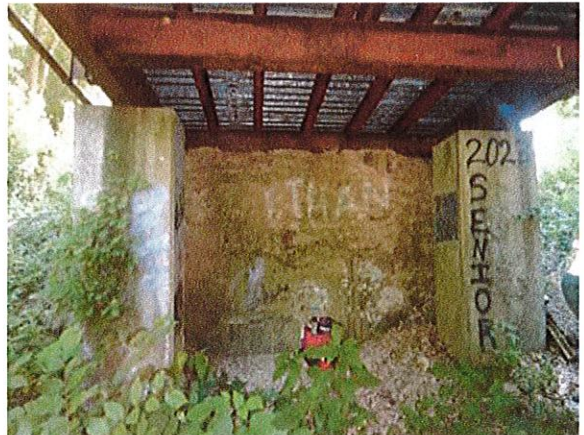
Bent 7 (south abutment): Original concrete abutment has heavy wear; concrete columns added in front to carry load from superstructure

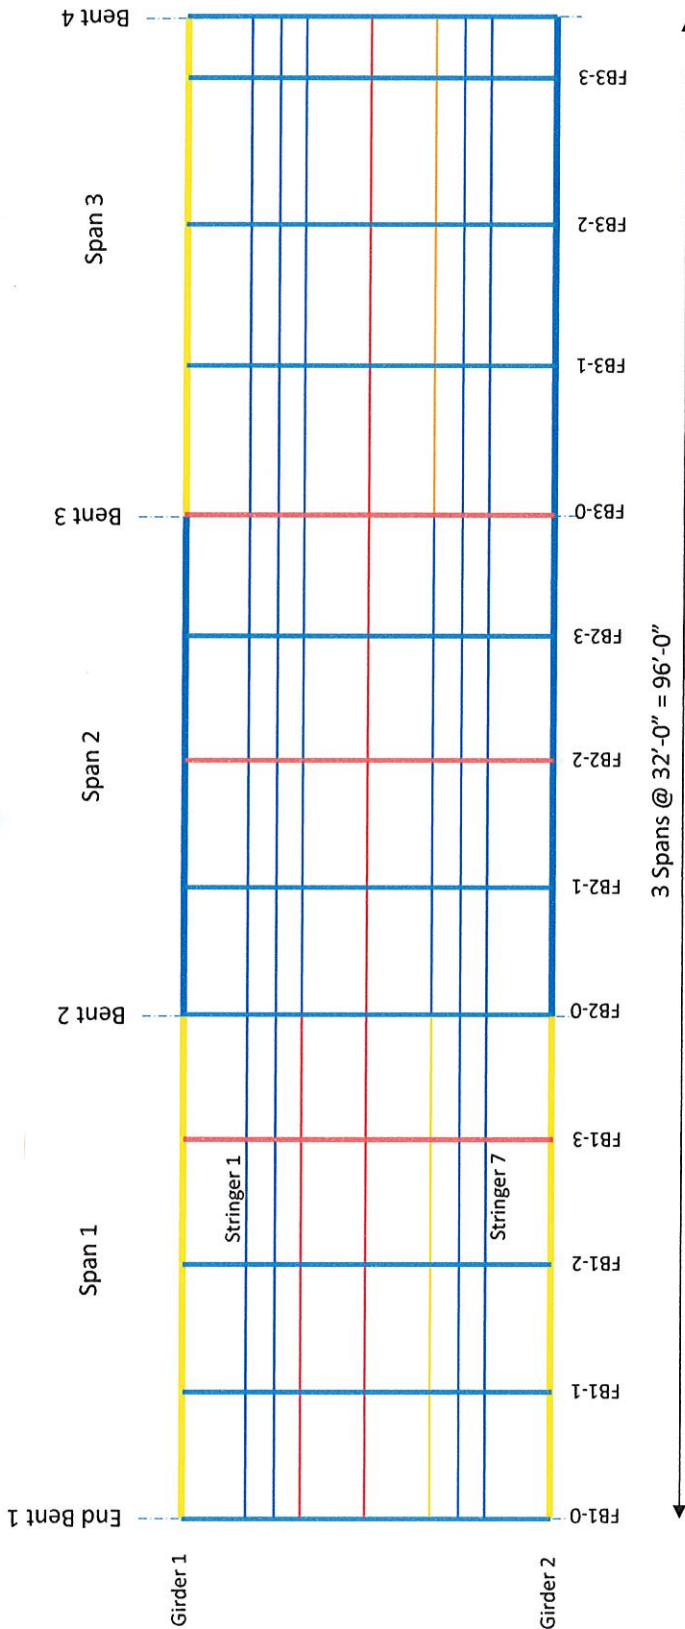
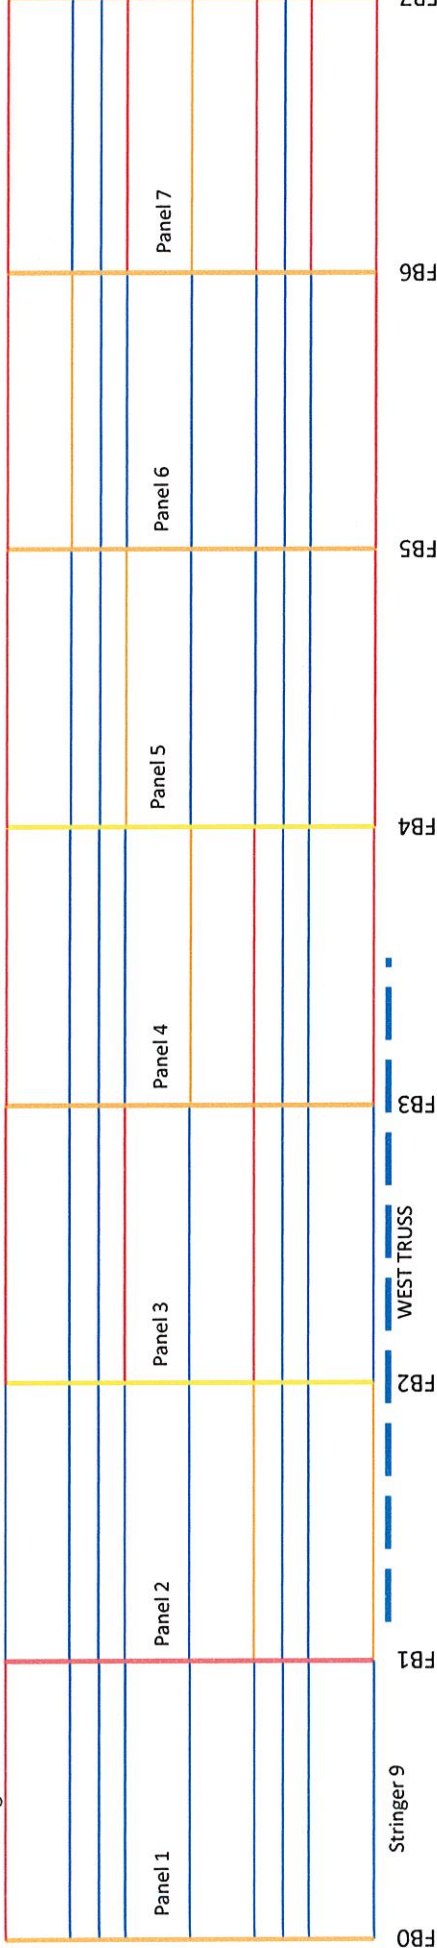
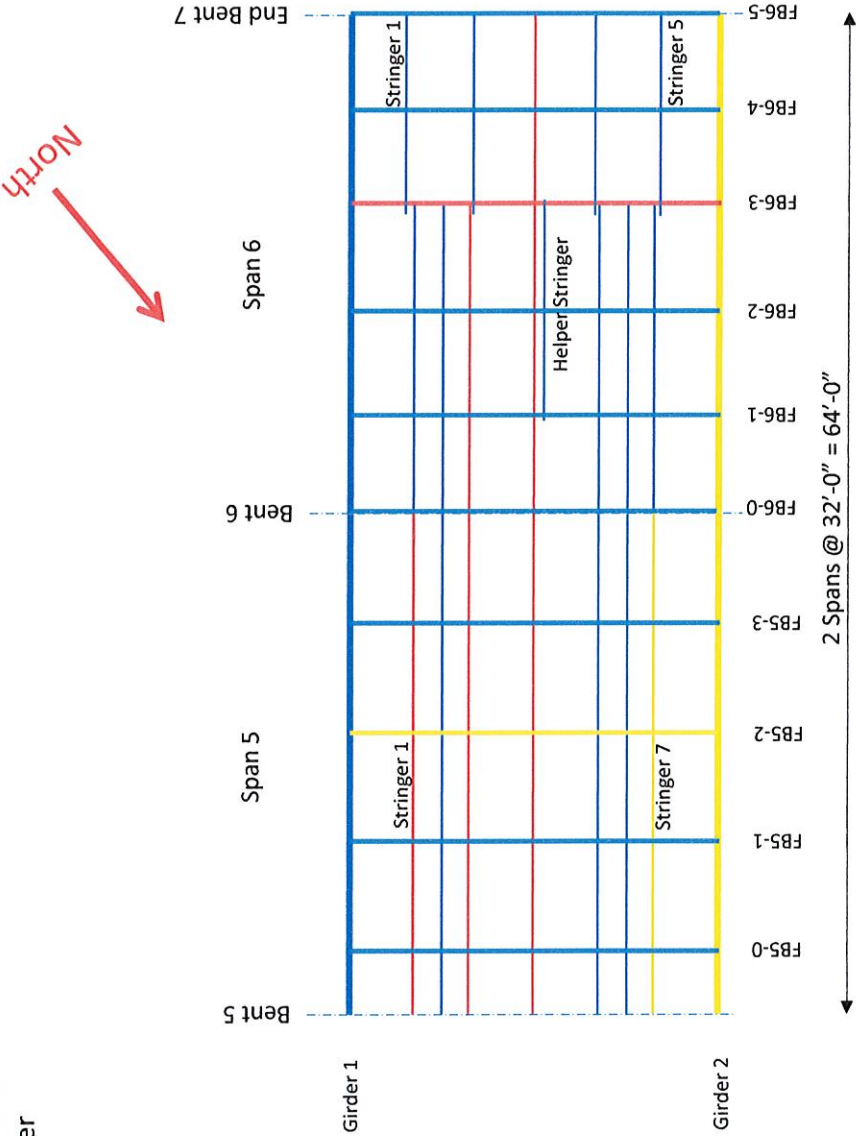
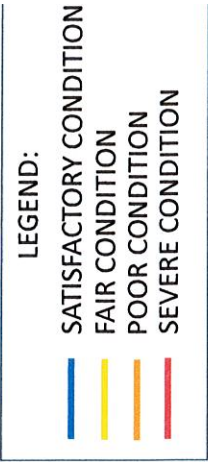
Figure 3: Condition of Floor System

There are multiple stringers and floor beams in poor or severe condition on this bridge. See **Figure 3, Condition of Floor System, in the Appendix**, for a layout and condition of the stringers and floor beams that comprise the floor system of the bridge.

There are several non-fracture critical members in the North Approach Spans, Spans 1 to 3, that are in serious/severe condition due to advanced section loss—see the red members in **Figure 3, Condition of Floor System, in the Appendix.**

There are several non-fracture critical members in the South Approach Spans, Spans 5 to 6, that are in serious/severe condition due to advanced section loss-- see the red members in **Figure 3, Condition of Floor System, in the Appendix.**

There are several non-fracture critical members in the Thru Truss Span, Span 4, that are in serious/severe condition due to advanced section loss. This includes the majority of the exterior stringers, and multiple interior stringers. See the red members in **Figure 3, Condition of Floor System, in the Appendix.**

**This bridge has reached the end of its service life, and we recommend that this bridge be closed to traffic.** Repairs of the stringers and floor beams would be difficult to achieve and are not recommended. Bridge replacement is recommended. By closing the Smyrna Road crossing of the Finley River, the additional travel for a detour to the west is about 7 miles, and a detour to the east is about 8 miles.

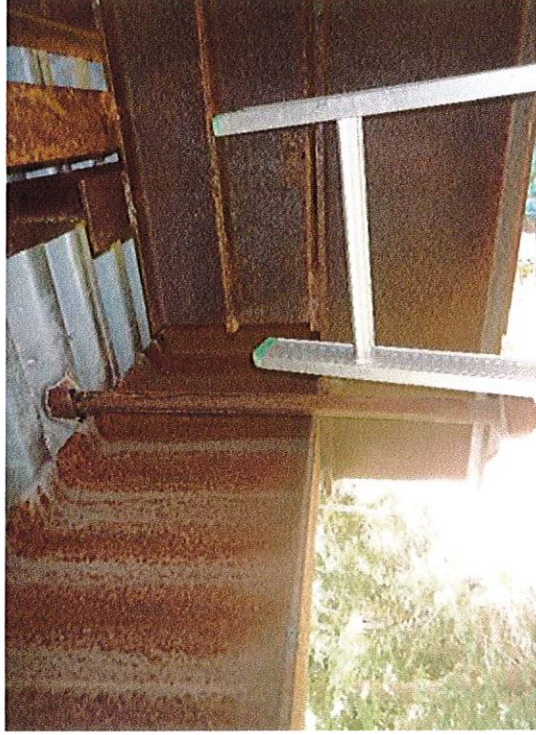
**PHOTO 7** SPAN 1, FLOOR BEAM 2: Hanger rods used to support floor beam

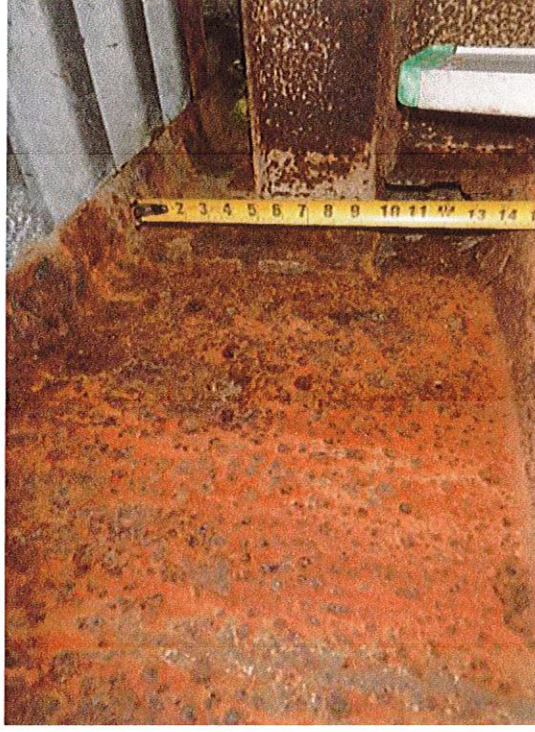
**PHOTO 6** SPAN 1, WEST GIRDER, NEAR BENT 1: Heavy pitting with section loss for 7' length (9" height x 1/8" deep)

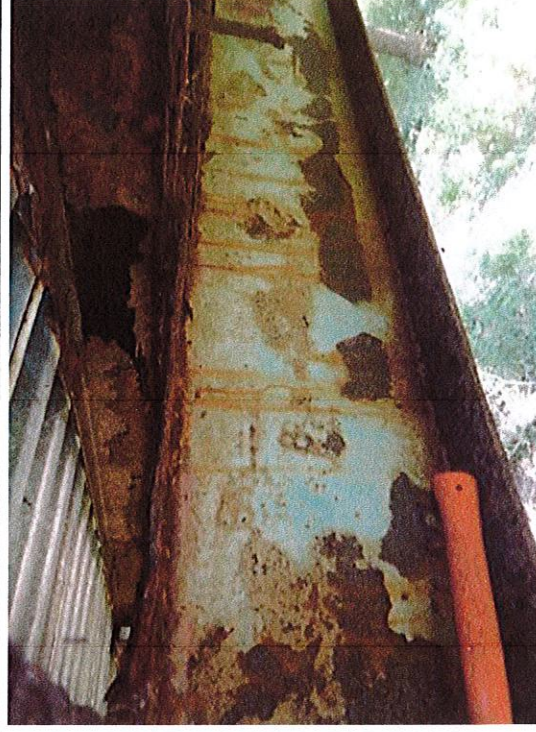
**PHOTO 8** SPAN 1, FLOOR BEAM 3: 50% section loss to bottom flange for west 2' ; 1/4" average thickness remaining for top flange for center half of floor beam

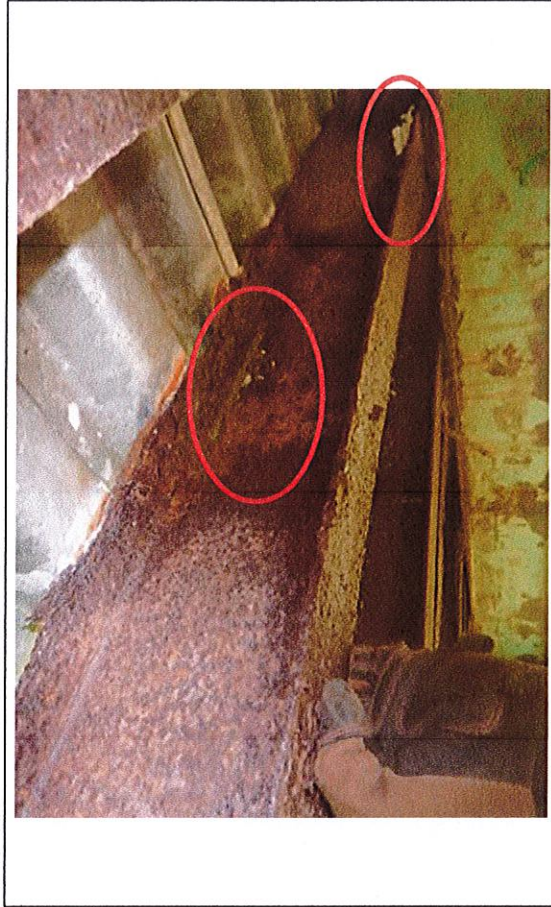
PHOTO 10 SPAN 1, STRINGER 3: 2" x 14" hole top of web & 100% top flange sect. loss starting 16" S. of FB 3; 2.5" x 15" hole bot. of web & 100% top flange sect. loss over FB 3

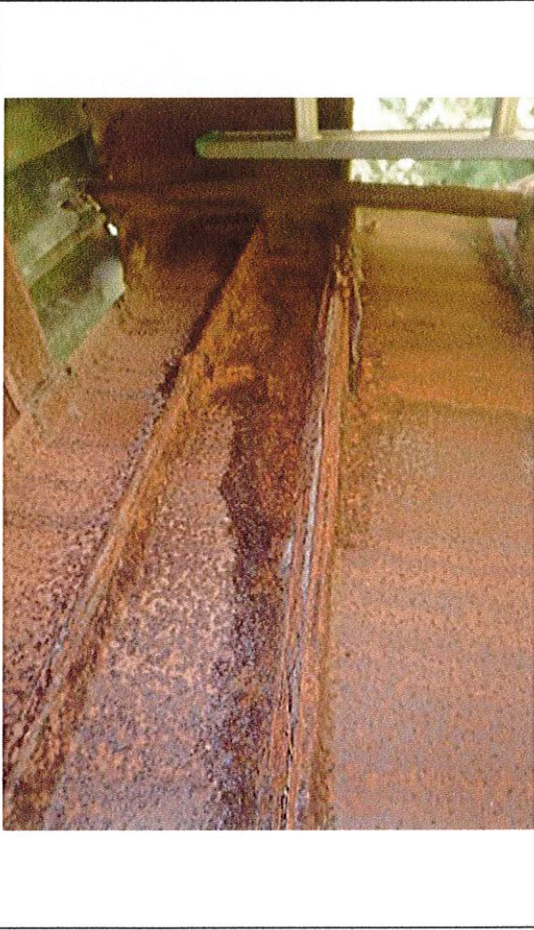
PHOTO 11 SPAN 2, FLOOR BEAM 2: Center member (spacer member) has large corrosion hole at west end

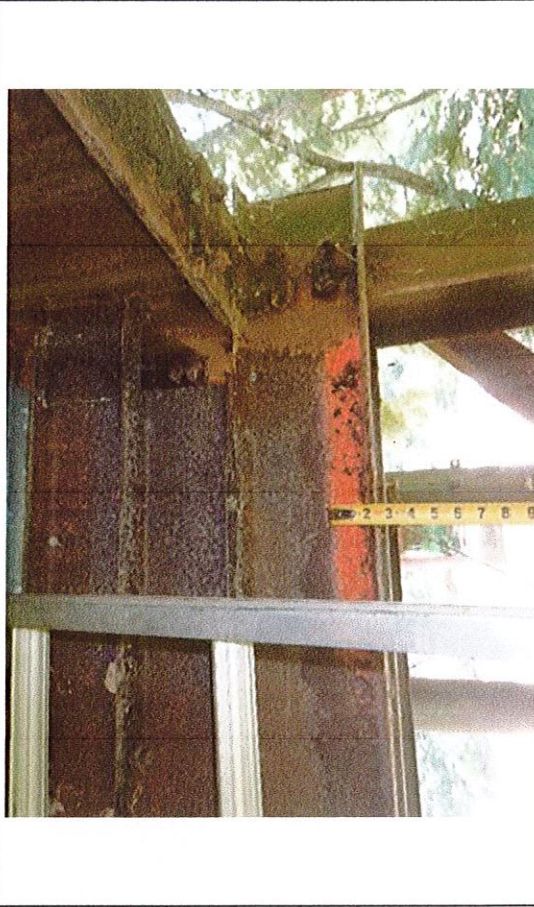
PHOTO 12 BENT 3 CAP, WEST END: 2.5" x 18" long corrosion hole in web

make repairs to lower stacked channel at Bent 3

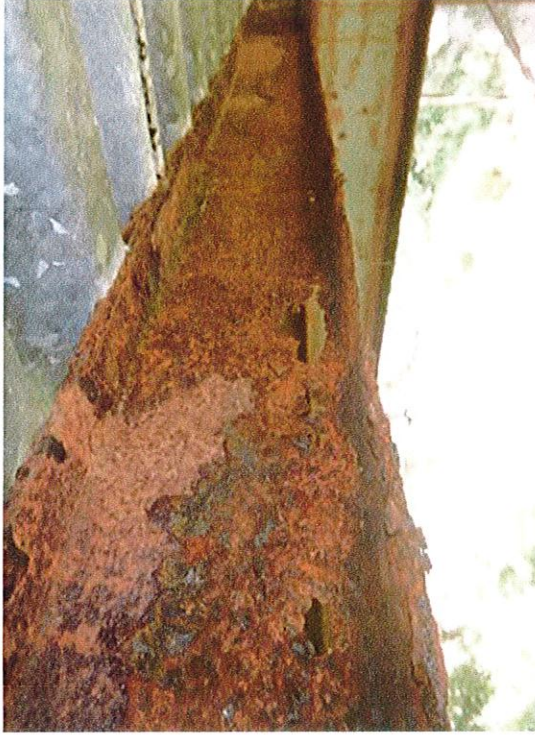
**PHOTO 13** SPAN 2, STRINGER 4: 80% section loss to web and bottom flange

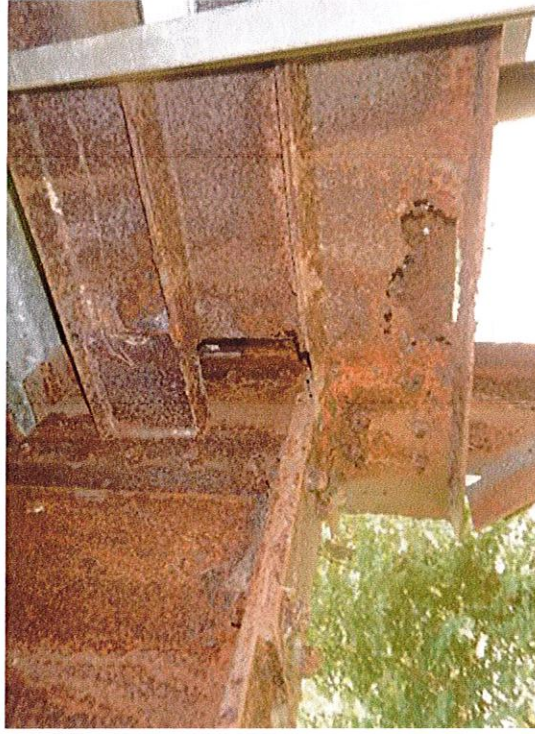
**PHOTO 14** BENT 3 CAP, EAST END: 50% section loss to cap (typical north and south cap member)

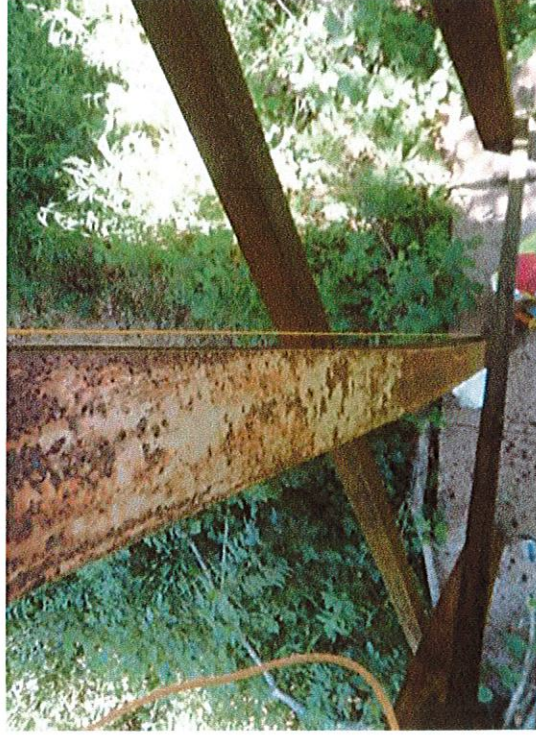
**PHOTO 15** BENT 3, PILE 3: Pile is bent 1 1/8" out of plane

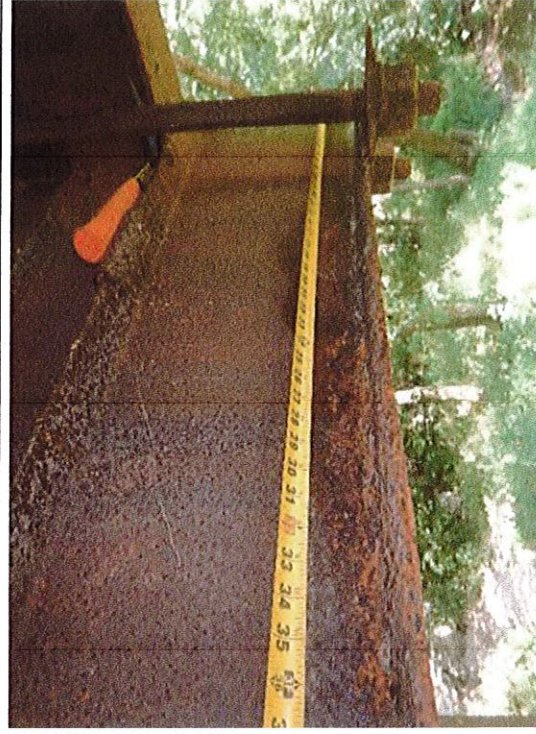
**PHOTO 16** SPAN 2, FLOOR BEAM 2: 50% section loss to lower member bottom flange for east 3' of member

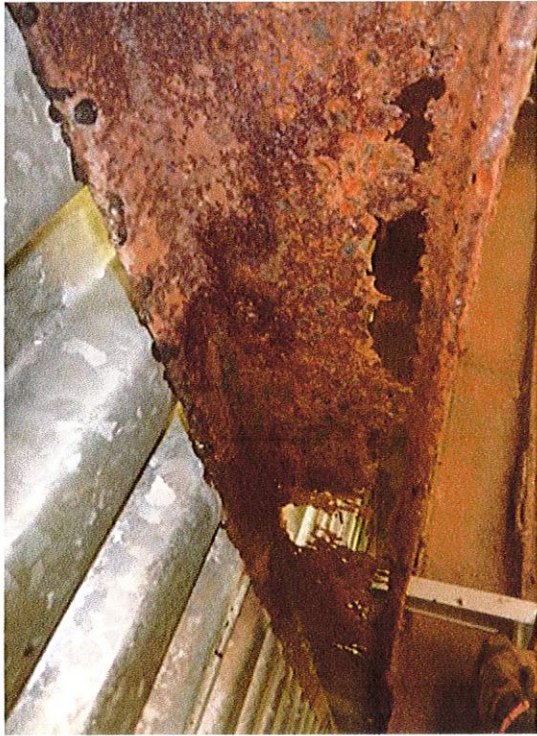
PHOTO 17 SPAN 3, PANEL 1, STRINGER 4: 80% section loss to member

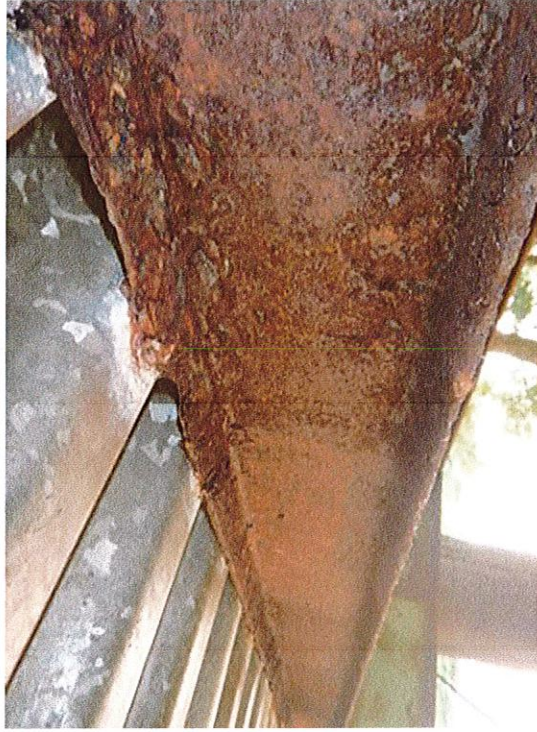
PHOTO 18 SPAN 3, PANELS 3 & 4, STRINGER 5: 50% section loss in member

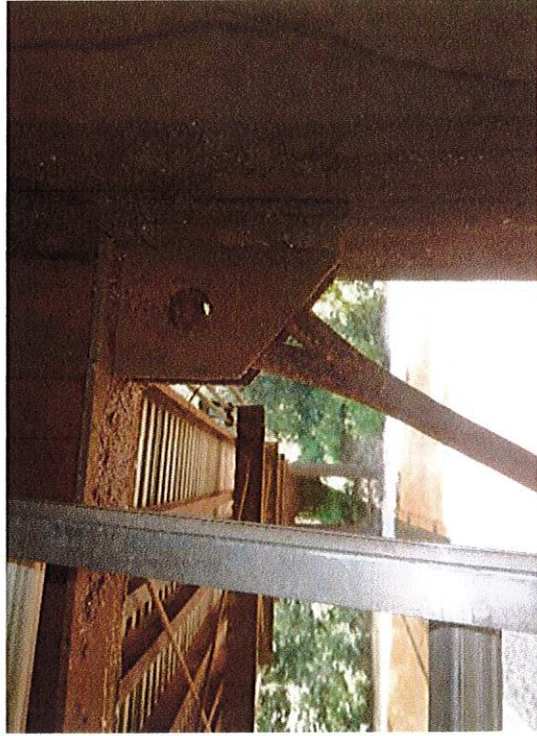
PHOTO 19 BENT 4: Missing pin at top of bent X bracing

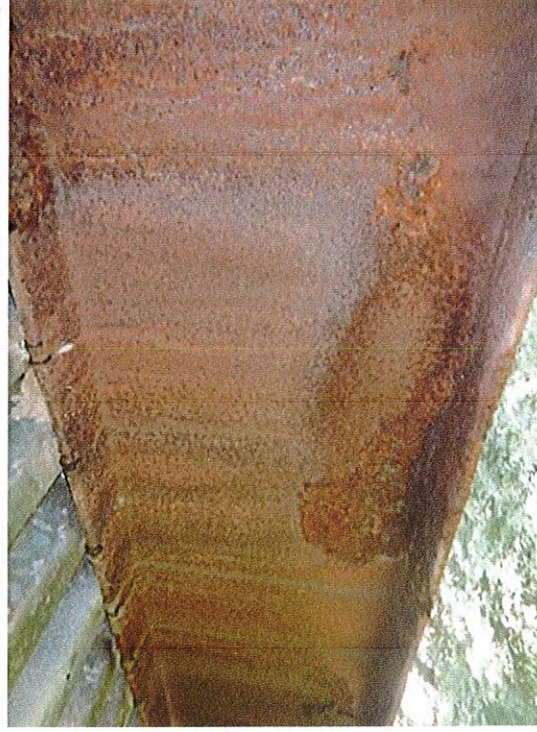
PHOTO 20 SPAN 2, WEST GIRDER: Intermittent locations of 6" tall x 1/8" deep section loss to web

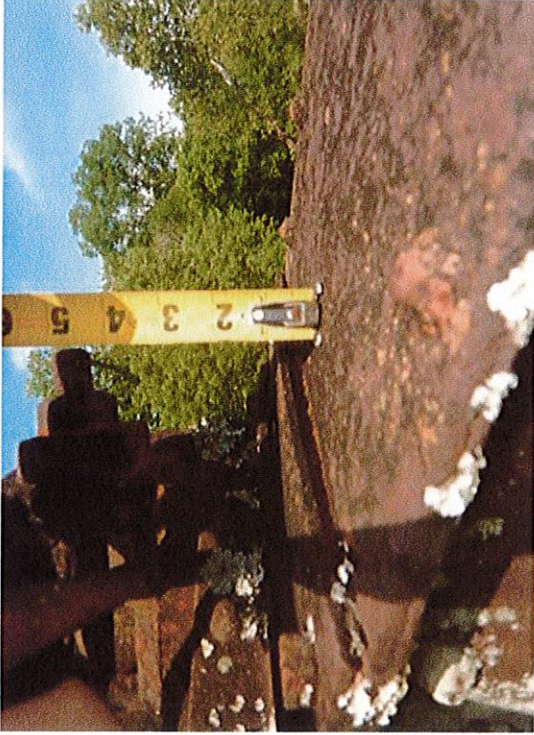
**PHOTO 21** SPAN 4, UPPER CHORD: Typical minor pack rust jacking at upper chord panel points

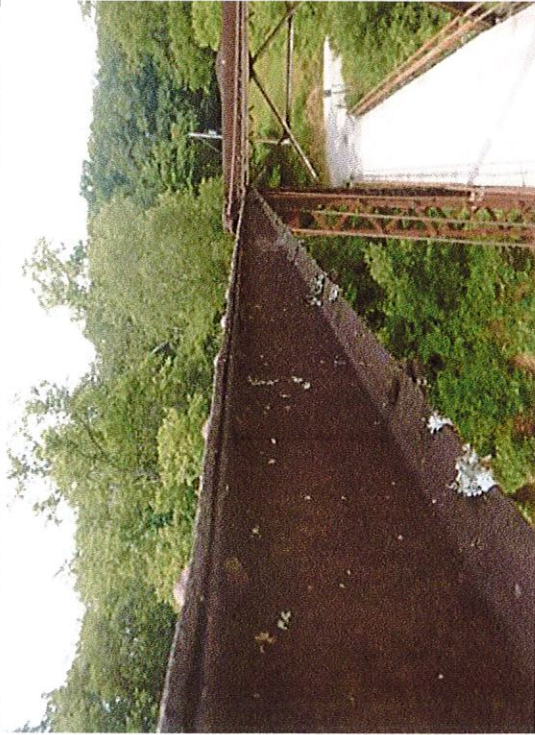
**PHOTO 23** SPAN 4: Typical minor rippling of upper chord cover plate

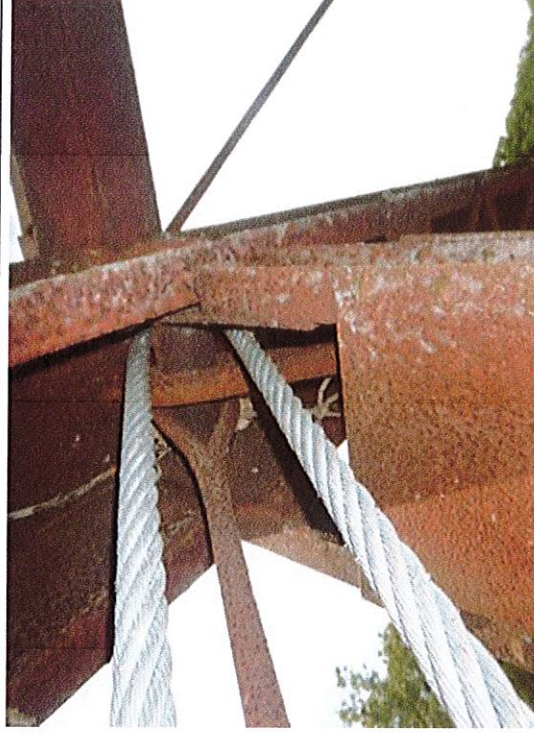
**PHOTO 22** SPAN 4, EAST TRUSS, L2-U3: Wire rope sister member added

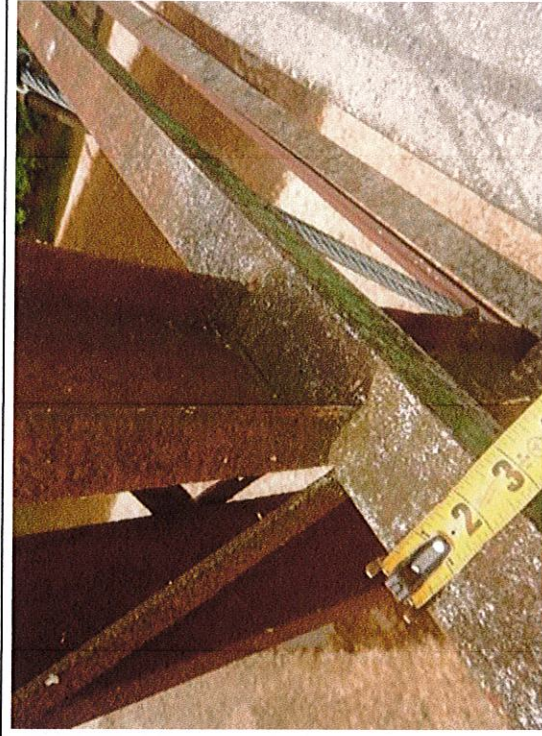
**PHOTO 24** SPAN 4: Railing welded to vertical member (typical)

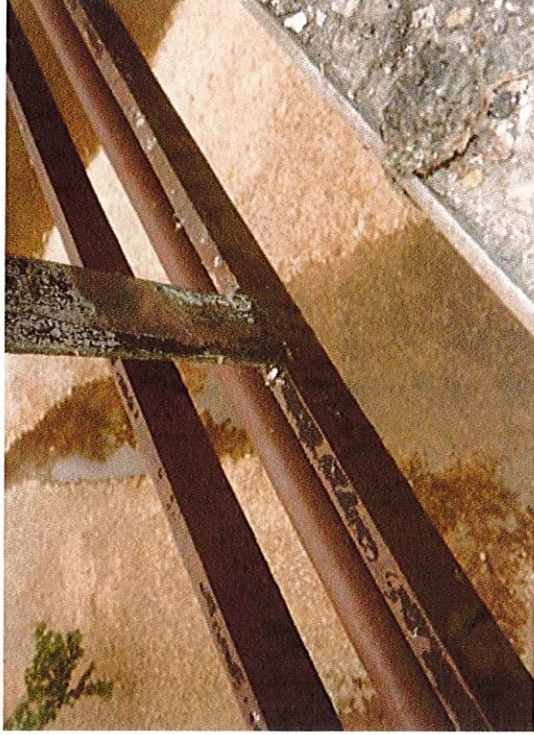
**PHOTO 25** SPAN 4: Railing member welded to lower chord (typical)

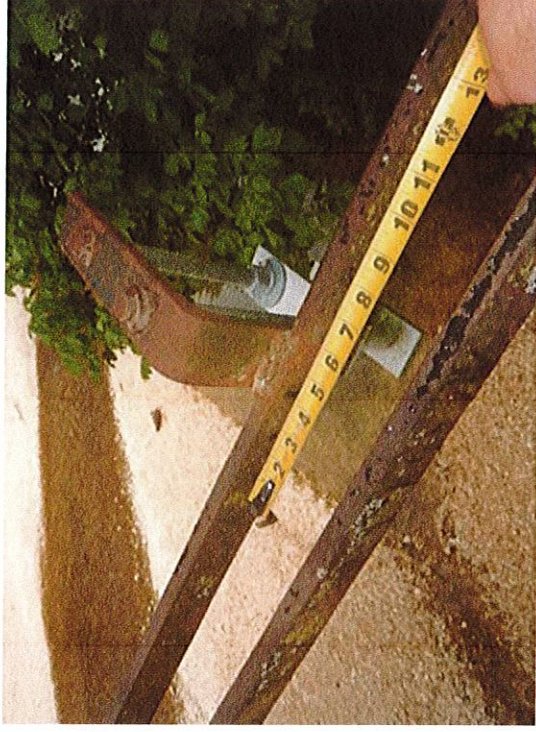
**PHOTO 26** SPAN 4: Utility attachment welded to lower chord (typical)

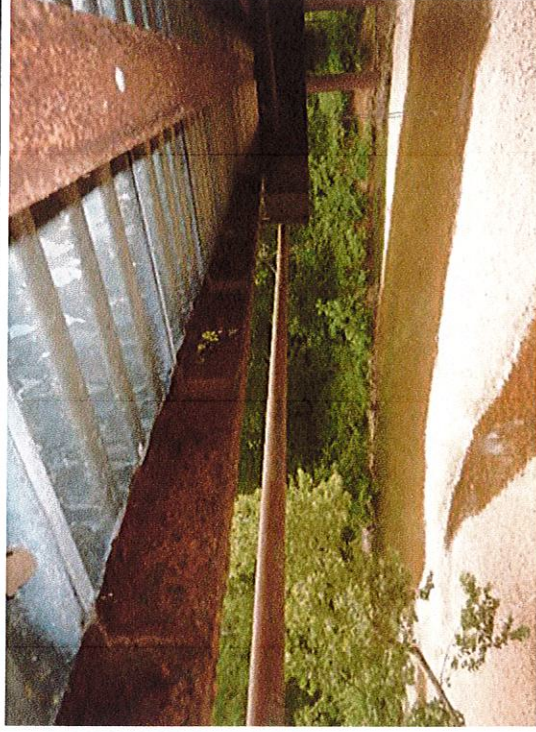
**PHOTO 28** SPAN 4, PANEL 1, STRINGER 1: Severe corrosion and section loss in stringer

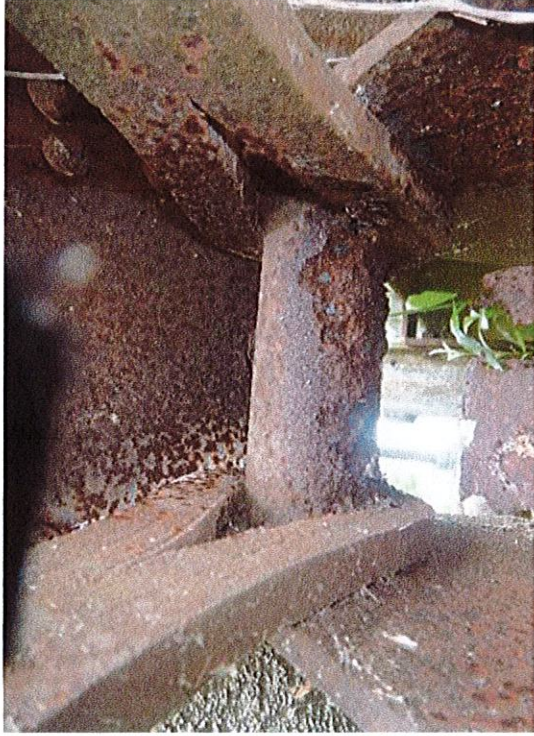
Most of the pins in the lower chord have heavy surface rust but are in fair condition. The pins at L0 on both trusses are in poor condition with 1/8 to 3/16" pitting (**see photo below**).

**PHOTO 29** SPAN 4, WEST TRUSS, LO: Pin has 3/16" deep pitting on 1/4" of the pin circumference for 2/3 of pin length

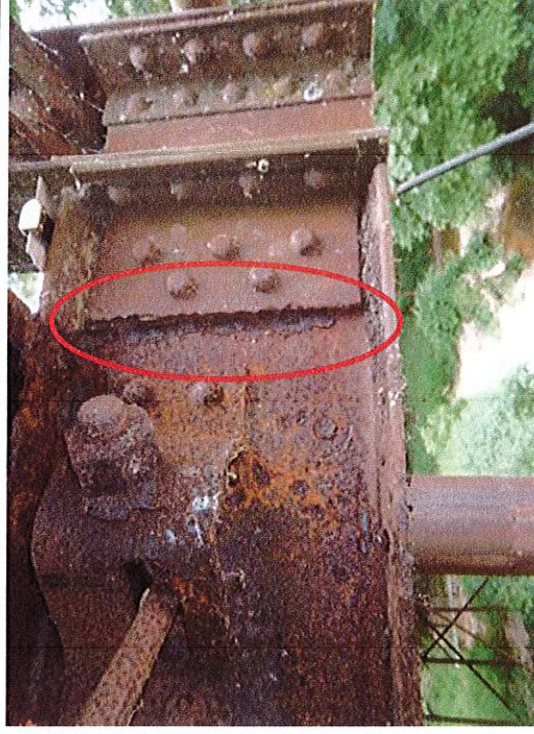
**PHOTO 30** SPAN 4, FLOOR BEAM 1, EAST END, SOUTH FACE: Heavy section loss in web at end of clip angle connection

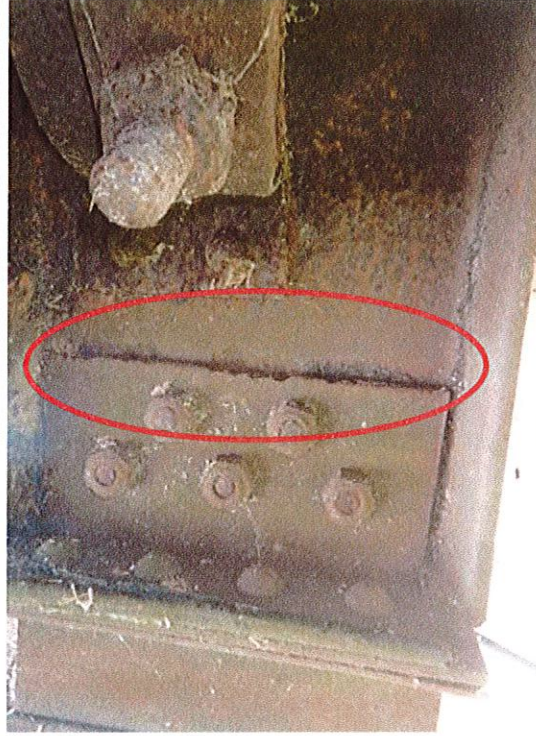
**PHOTO 31** SPAN 4, FLOOR BEAM 1, EAST END, NORTH FACE: Heavy section loss in web at end of clip angle connection

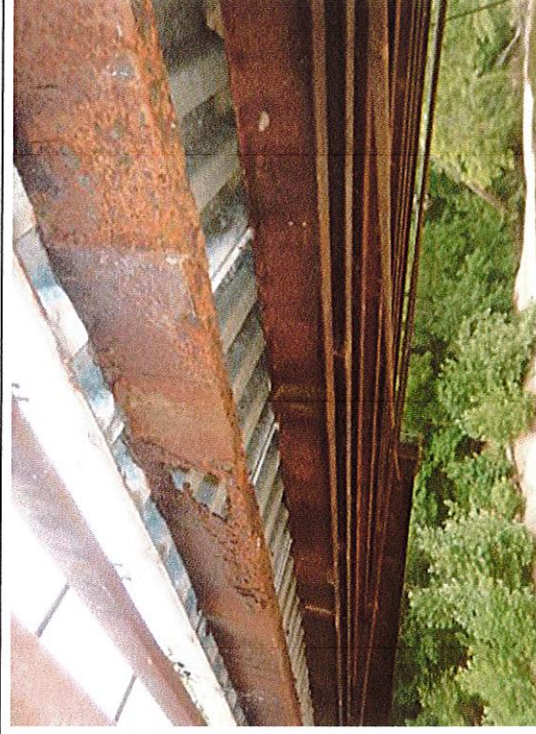
**PHOTO 32** SPAN 4, PANEL 3, STRINGER 1: Severe section loss in stringer

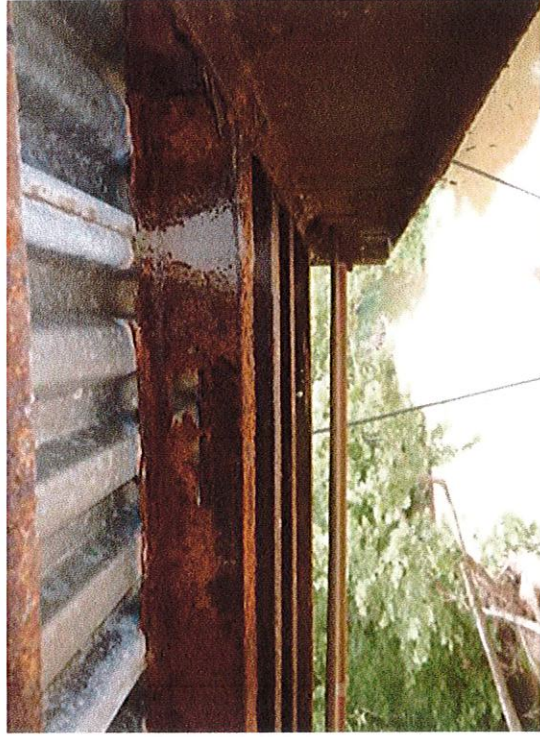
**PHOTO 33** SPAN 4, PANEL 3, STRINGER 4: Severe section loss in stringer

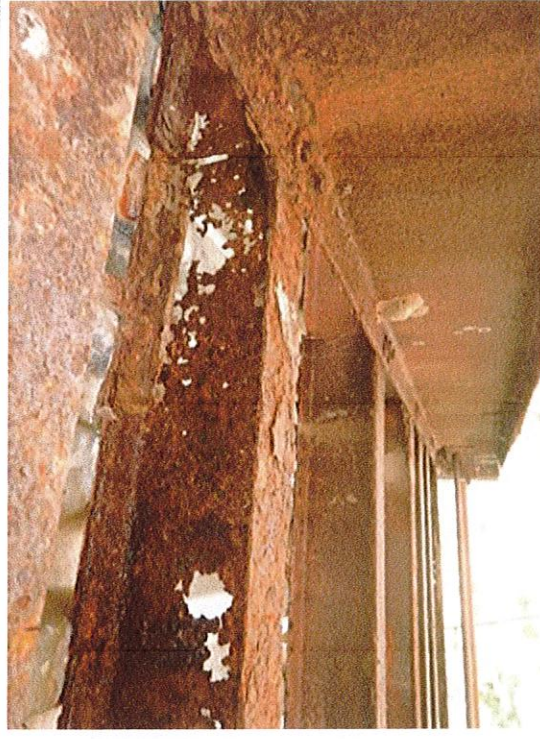
**PHOTO 34** SPAN 4, PANEL 3, STRINGER 6: Severe section loss in stringer

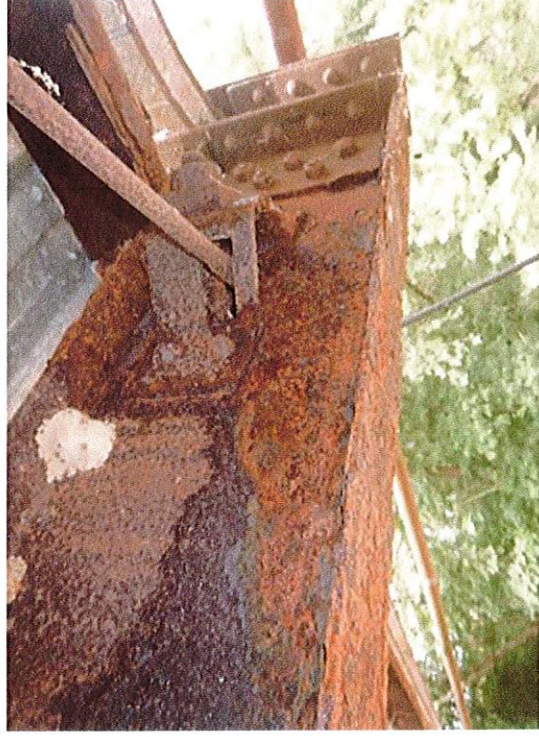
**PHOTO 35** SPAN 4, FLOOR BEAM 3, EAST END: Bottom flange has 40% section loss, web has 1/8" section loss

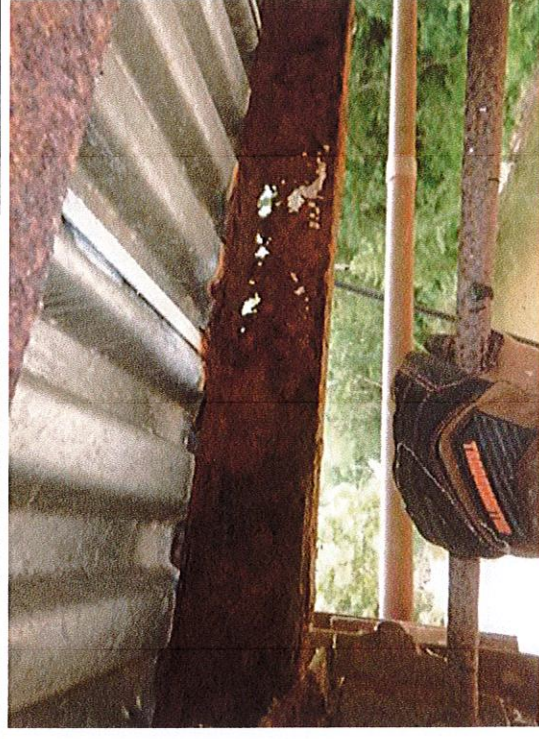
**PHOTO 36** SPAN 4, PANEL 4, STRINGER 1: Severe section loss in stringer

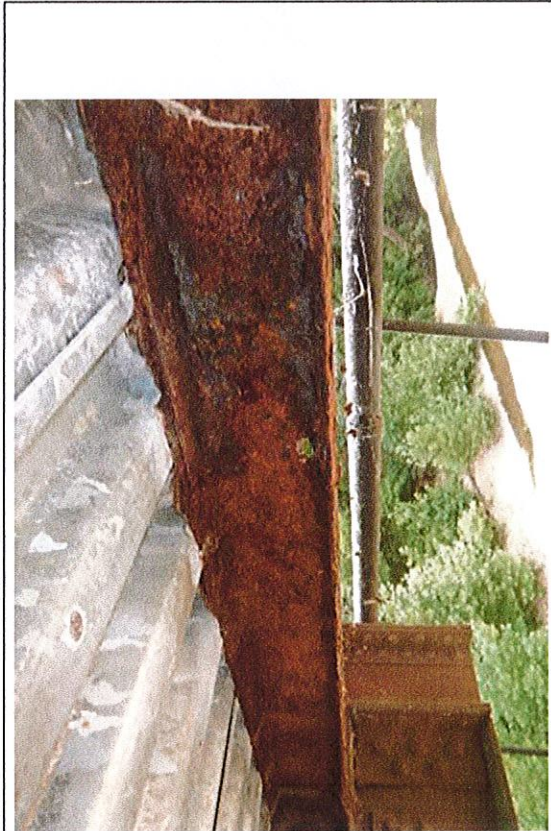
PHOTO 37 SPAN 4, PANEL 4, STRINGER 9: Severe section loss in stringer

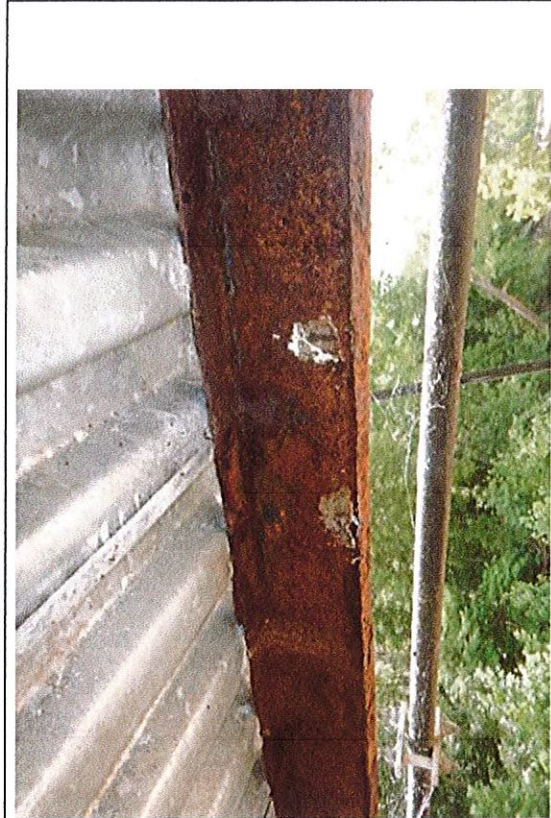
PHOTO 38 SPAN 4, PANEL 5, STRINGER 9: Severe section loss in stringer

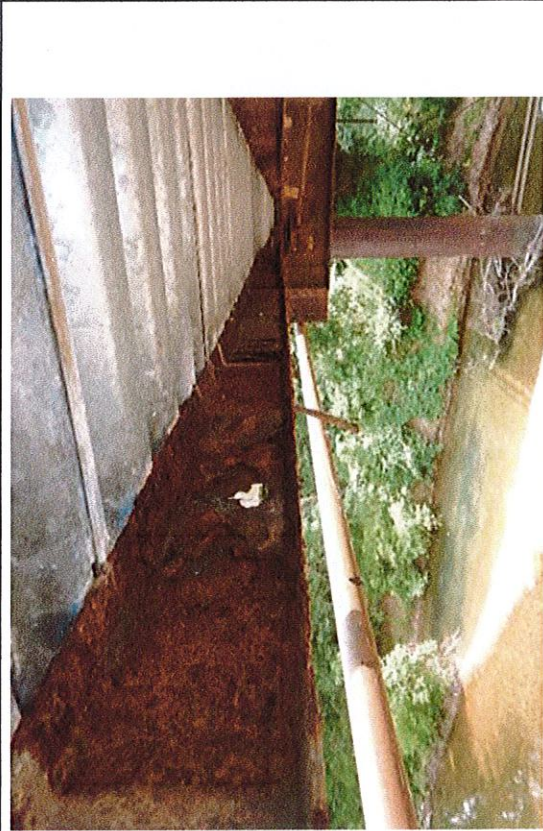
PHOTO 39 SPAN 4, PANEL 5, STRINGER 1: Severe section loss in stringer

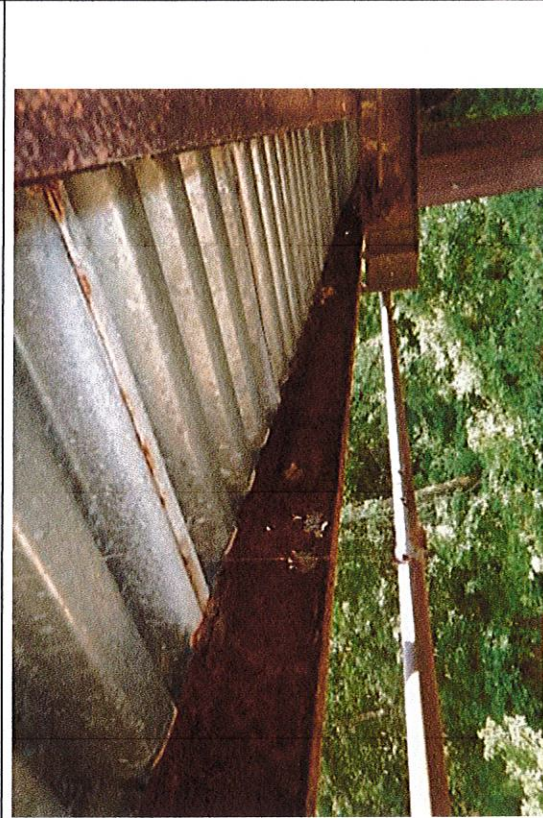
PHOTO 40 SPAN 4, PANEL 6, STRINGER 1: Severe section loss in stringer

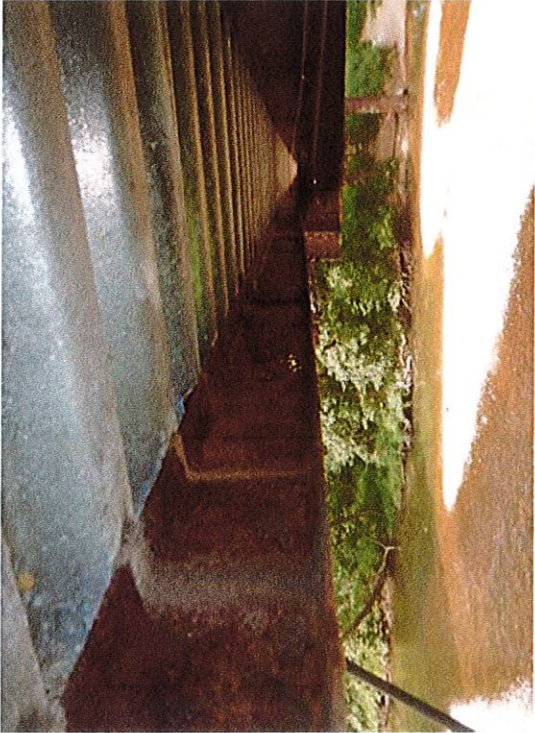
| | PHOTO 43 SPAN 4, PANEL 7, STRINGER 9: Severe section loss in stringer | | |
