**Fracture Critical  
Bridge Inspection Report**

**Bridge No. 2490003  
Christian County, Missouri  
Smyrna Road over Finley River**

**Prepared by H.W. Lochner, Inc.  
January 2024**

# Comprehensive Fracture Critical Bridge Inspection Report

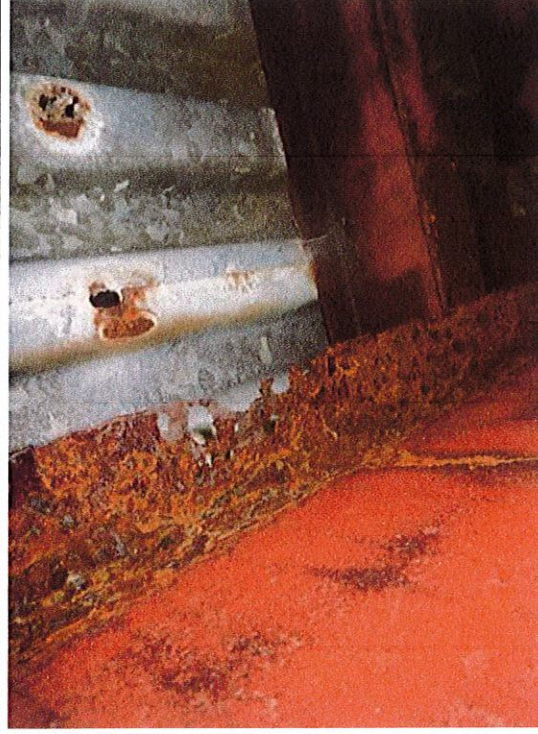
**PHOTO 46** SPAN 6, FLOOR BEAM 3: 50%-75% section loss to top flange about 30" from West Girder

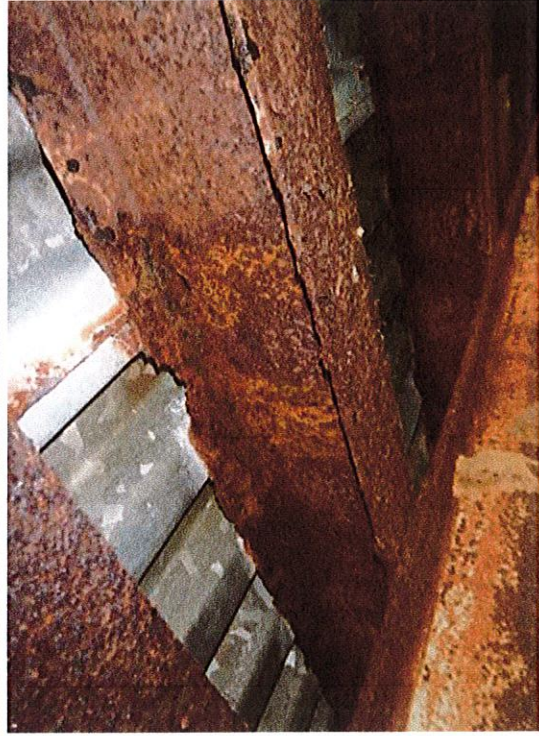
**PHOTO 47** SPAN 6, PANEL 1, STRINGER 3: 80% section loss to top flange just south of Floor Beam 1

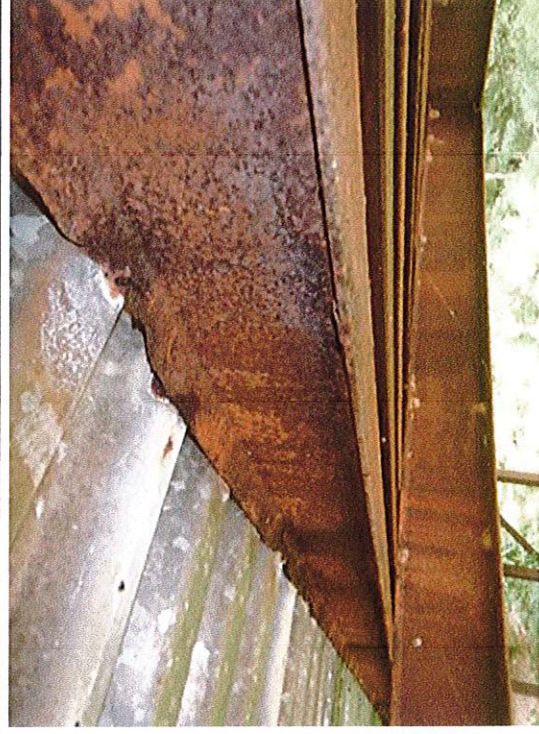
**PHOTO 48** SPAN 5, PANEL 2, STRINGER 1: 70% section loss to top flange

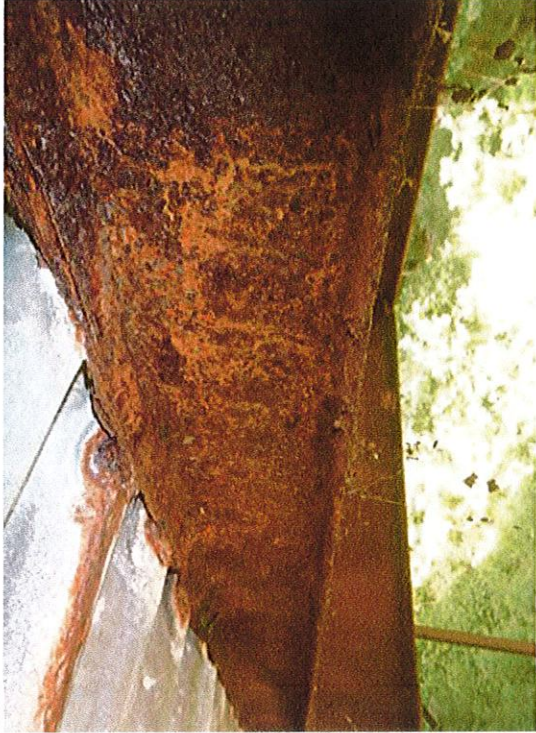
| | <b>PHOTO 49</b> SPAN 5, PANEL 2, STRINGER 4: 80% section loss to top flange and web,<br>50% section loss to bottom flange at center 3' of panel | | |
