## Christian County Commission

### MEETING ATTACHMENTS (ID # 4988)

# **Christian County Planning & Zoning Commission Recommendation & Staff Report To the County Commission**

## **A Recharge Area Delineation for Smallin Civil War Cave, Ozark, Missouri**

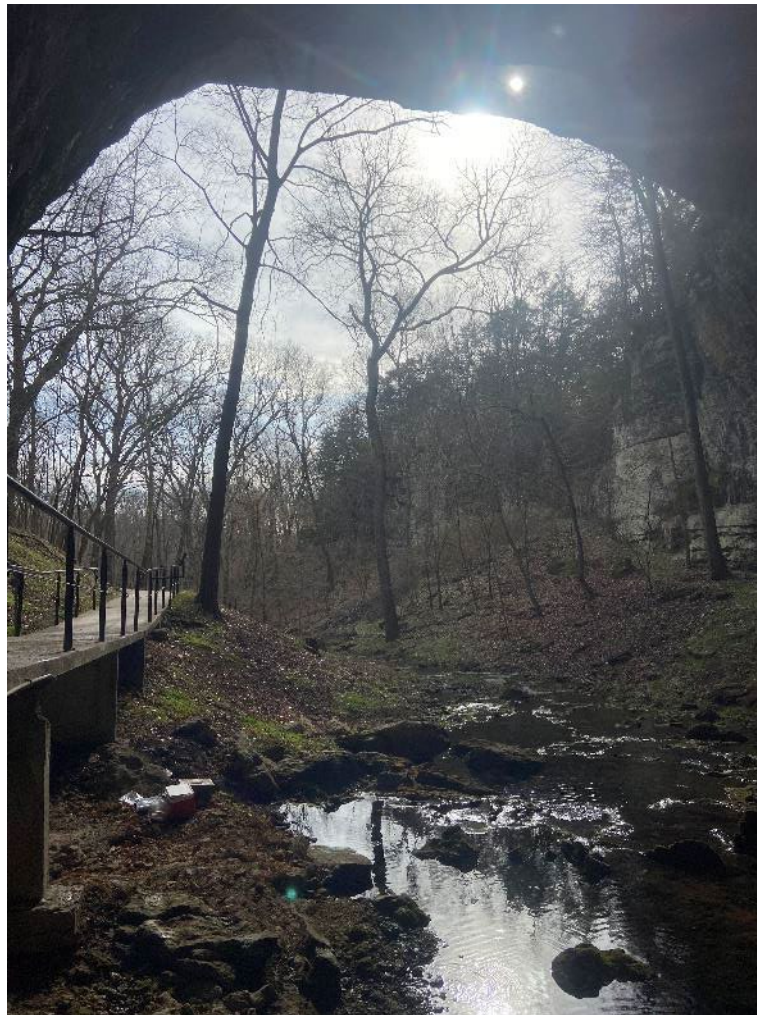
**Figure 1.** Smallin Cave viewed from the boardwalk inside the cave.

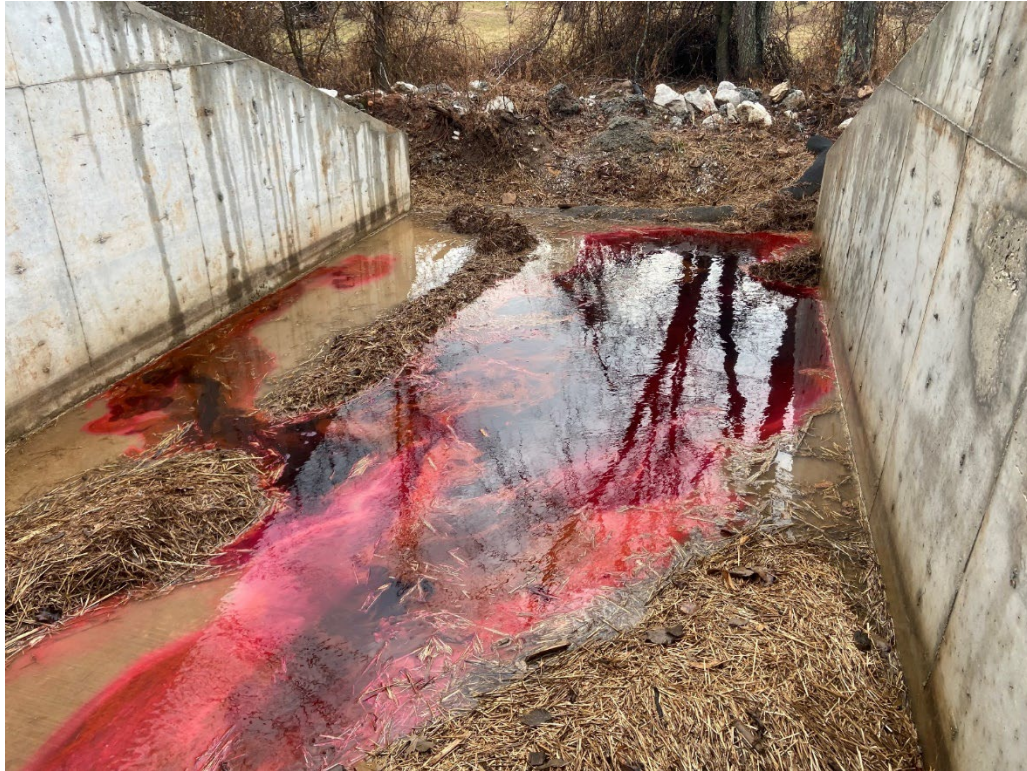
**Figure 5.** RWT dye introduced into the weir structure of a stormwater detention basin in the Northtown Park development.

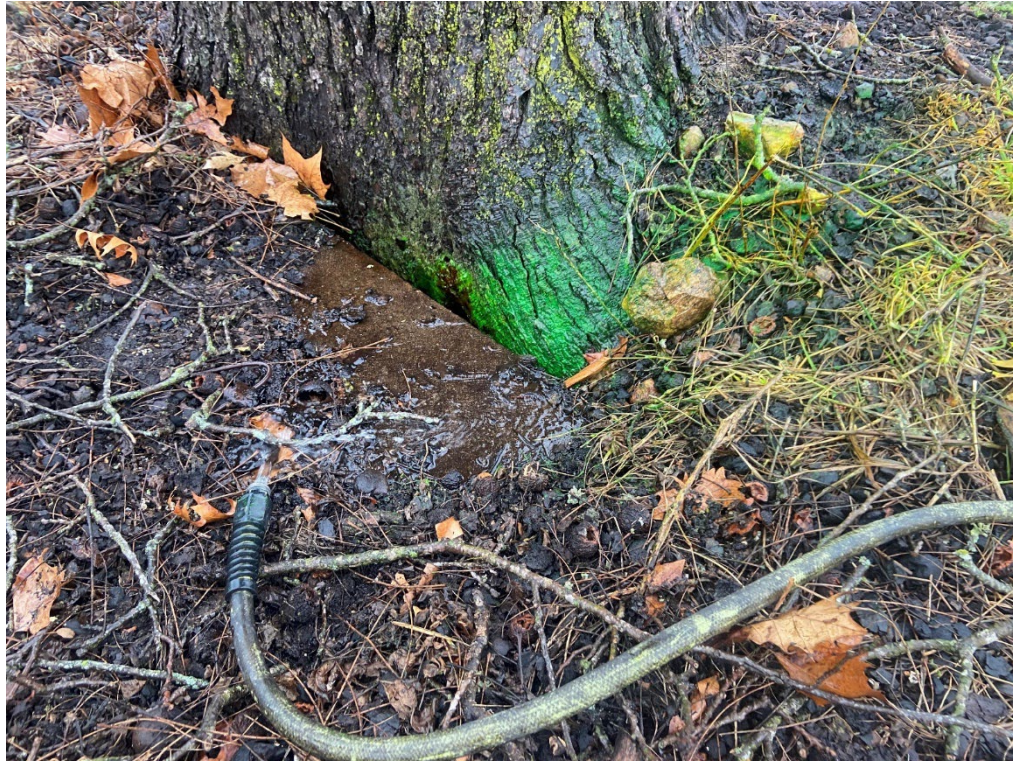
**Figure 7.** Flushing water behind Trace 23-02 with a garden hose. The small space between the tree and the slab covering the sinkhole allowed for the fluorescein introduction.

At 10:40 on January 18th, 2023, two pounds of fluorescein dye mixture containing 70% dye equivalent was introduced into a sinkhole located in a residential yard in an unnamed tributary to Parched Corn Hollow. The purpose of this trace was to determine the eastern boundary of the recharge area contributing water to Smallin Cave. The sinkhole had been covered with a concrete slab; however, a small crack allowed for the introduction of dye. There was no surface flow at the time of introduction, but water could be heard flowing beneath the concrete slab covering the sinkhole. Approximately 125 gallons of water was introduced along with the dye using a garden hose from a nearby residence.

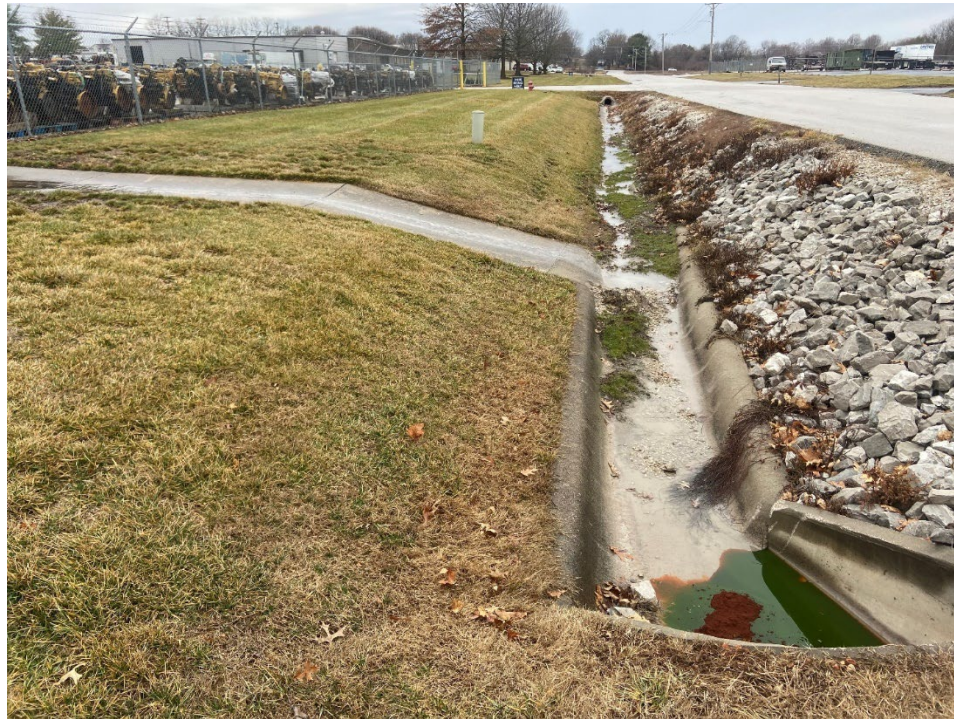
**Figure 10.** Eosine dye introduced into West Liberty Road culvert for Trace 23-04.

At 08:55 on February 7<sup>th</sup>, 2023, four pounds of eosine dye mixture containing 96% dye equivalent was introduced into a culvert on West Liberty Road that drains into an unnamed tributary to the James River. The purpose of this trace was to determine the northern boundary of the recharge area contributing water to Smallin Cave. Water flow in the culvert was approximately 3-5 gpm at the time of introduction.

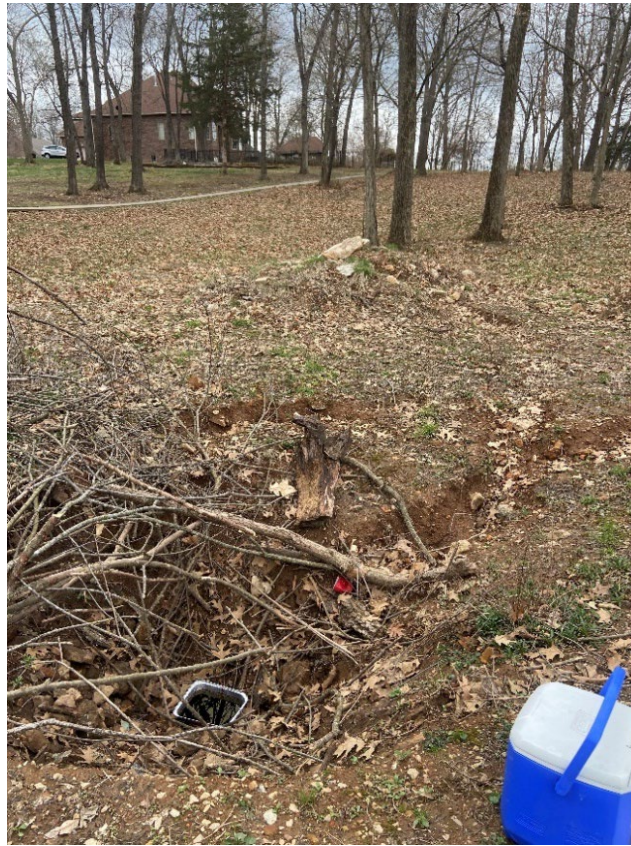
**Figure 12.** Dry set introduction of RWT into McGuffey Park sinkhole.

At 12:50 on March 23, 2023, three pounds of RWT dye mixture containing 21% dye equivalent was introduced as a dry set into a sinkhole basin in McGuffey Park in anticipation of forecast precipitation that evening. The purpose of this trace was to determine the western boundary of the recharge area contributing water to Smallin Cave. The dry set was achieved by placing the RWT dye into a shallow disposable baking pan at the bottom of the sinkhole depression so that storm flow would mobilize the dye. There was no flow at the time of introduction.

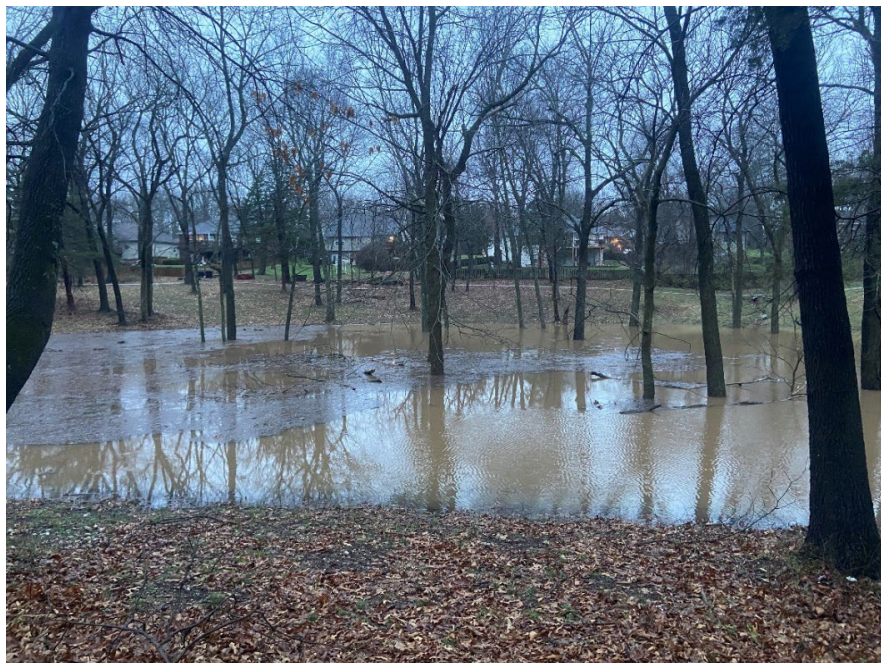
**Figure 13.** Mobilization of RWT dye by storm flows approximately 12 hours after introduction.

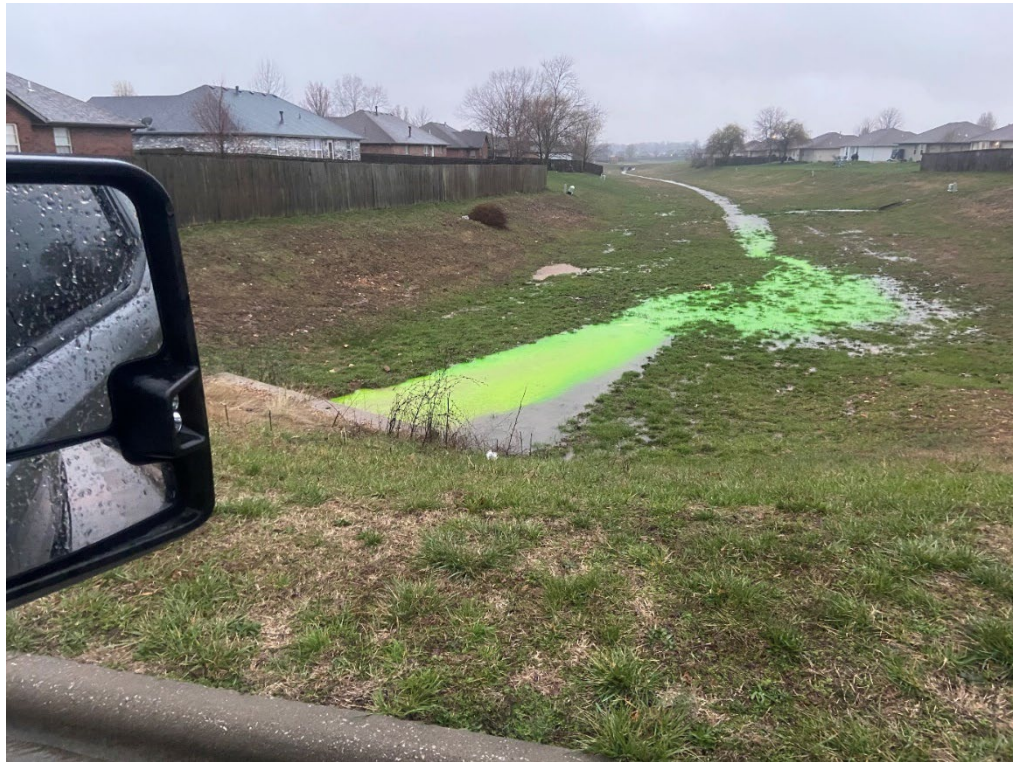
**Figure 15.** Mobilization of fluorescein dye by storm flows six hours post-introduction for Trace 23-06.

At 13:14 on March 23rd, 2023, two pounds of fluorescein dye mixture containing 70% dye equivalent was introduced into a stormwater culvert under 13<sup>th</sup> Avenue in The Rivers subdivision. The purpose of this trace was to determine the northernmost boundary of the area contributing water to Smallin Cave. The fluorescein was introduced as a dry set in anticipation of precipitation forecasted that evening. The dry set was achieved by placing the powdered dye mixture into the stream substrate in the road culvert. Surface flow from this location runs through a stormwater conveyance in The Rivers and Waterford subdivisions and later flows into an unnamed tributary to the James River. There was no flow at the time of introduction. Visual observation at 19:30 on March 23<sup>rd</sup>, 2023, verified that the dye was mobilized by stormflow six hours after introduction.

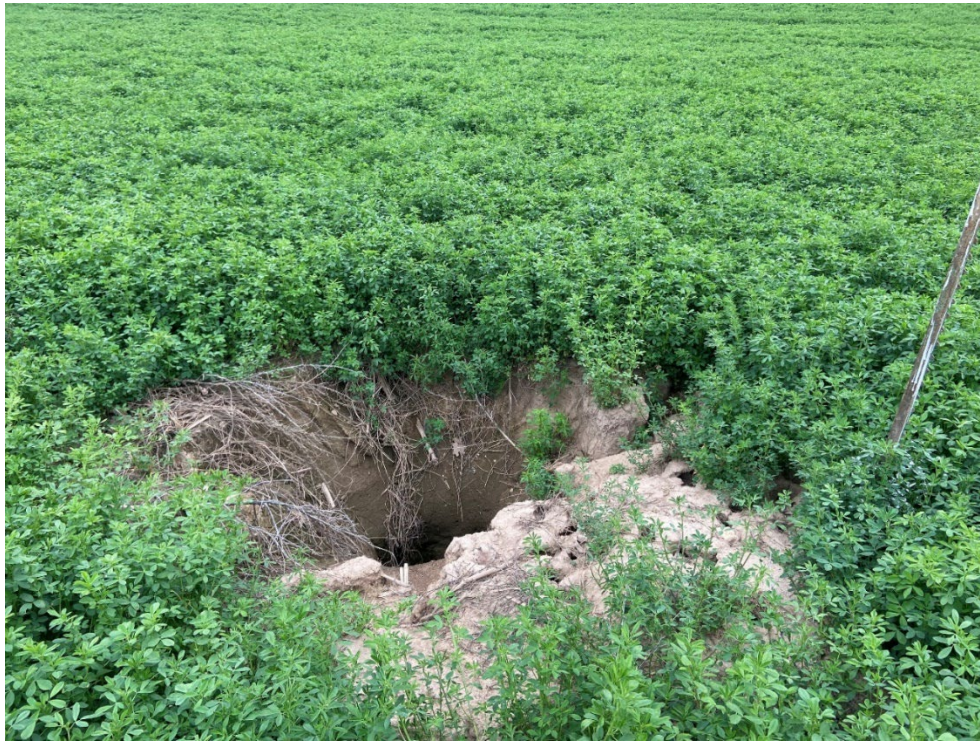
**Figure 17.** Trace 23-07 dye introduction location into a sinkhole in an alfalfa field at Wachsa Farms.

At 15:55 on May 4<sup>th</sup>, 2023, three pounds of eosine dye mixture containing 96% dye equivalent was introduced as a dry set into a sinkhole in an alfalfa field on Wacha Farms. The purpose of this trace was to determine the northernmost boundary of the area contributing water to Smallin Cave. There was no flow at the time of introduction. The dry set was achieved by pouring the eosine dye mixture into the sinkhole in anticipation of storm flow forecasted for that evening. Approximately 1.75 inches of rain fell in the area overnight after the introduction.

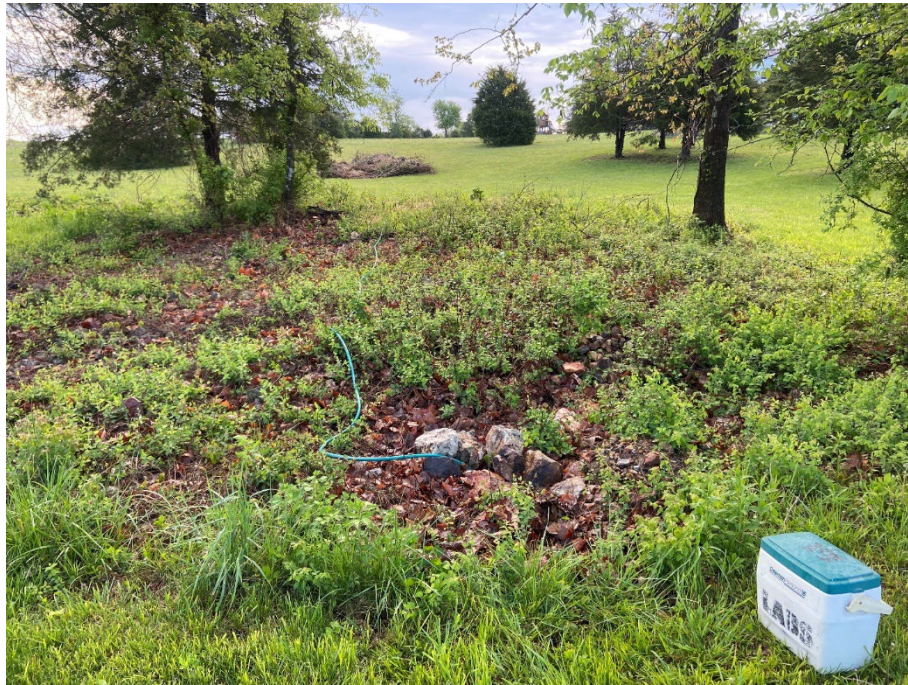
**Figure 19.** Trace 23-08 dye introduction location in a sinkhole on residential property on Indian Valley Road.

At 07:45 on May 5<sup>th</sup>, 2023, four pounds of RWT dye mixture containing 21% dye equivalent was introduced into a sinkhole on a residential property on Indian Valley Road. The purpose of this trace was to determine the western extent of the area that contributes water to Smallin Cave. There was no flow at the time of introduction. The dye was introduced directly into the sinkhole along with approximately 240 gallons of water from a garden hose from the nearby residence. Approximately 1.75" of rain fell in the area overnight before the introduction.

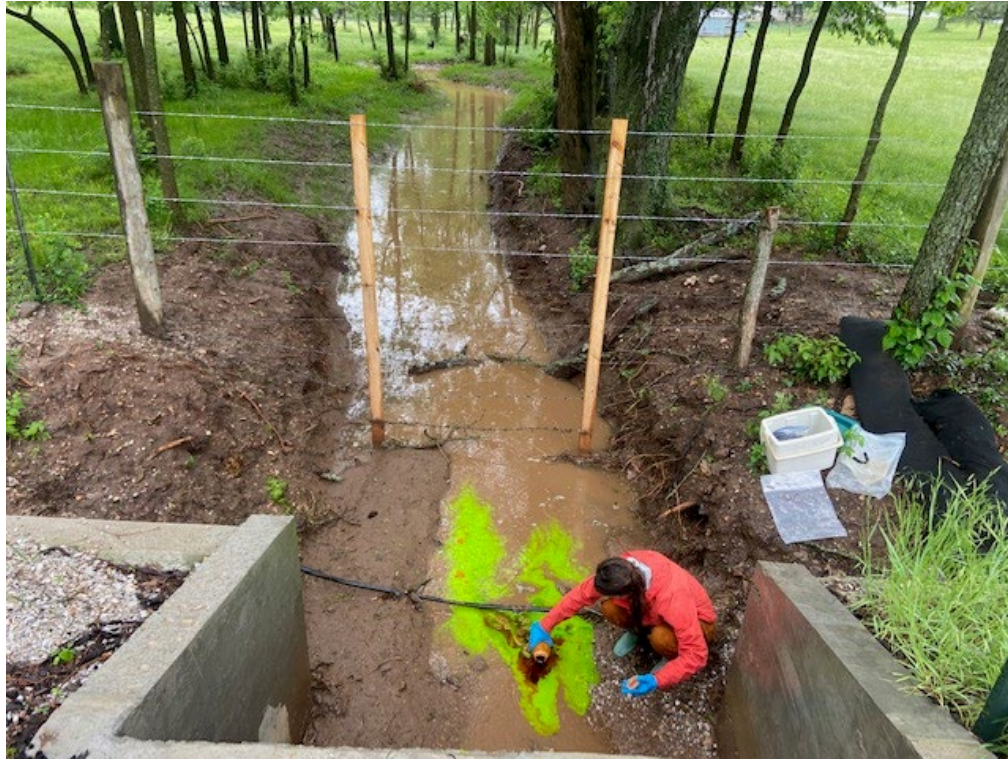
**Figure 22.** Fluorescein dye introduction at Hemlock Road into a losing stream. The stream disappears 75 feet downstream of the introduction point. Note the abundance of sediment suspended in the water.

At 10:22 on May 11<sup>th</sup>, 2023, 100 grams of fluorescein dye mixture containing 70% dye equivalent was introduced into a losing stream reach flowing through a culvert under Hemlock Road. The purpose of this trace was to determine the source of sedimentation in Fielden Cave following storm flow events near the cave. At the time of introduction, the target stream had a high sediment load and flow was estimated to be 10-15 gpm. A solution consisting of fluorescein dye and one liter of water was introduced directly into the water flowing through the culvert. The stream flow disappeared approximately 75 feet downstream of the road.

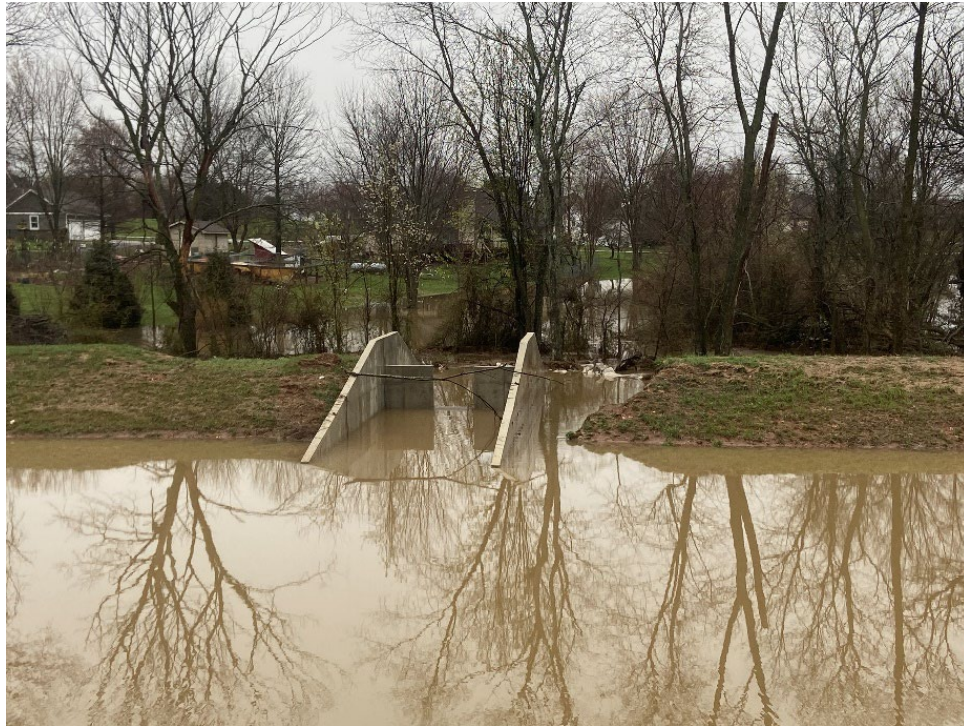
**Figure 29.** Structural failure of a stormwater detention basin full of sediment laden water. Note the breach in the dam just to the right of the concrete structure. Trace 23-01 was conducted at this location before the failure. Discharge from this structure contributes water directly to Smallin Cave.

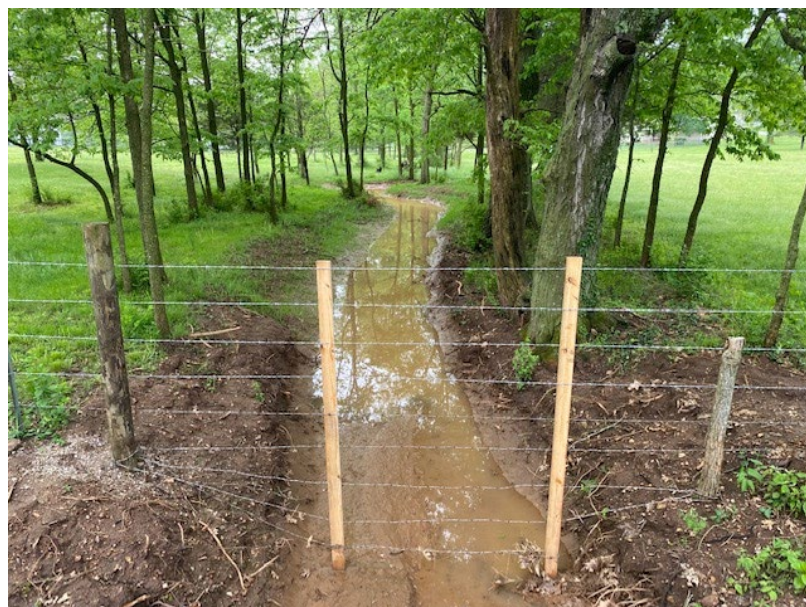
**Figure 30.** Excessive sedimentation in a losing stream that flows under Hemlock Road. The sediment is the result of inadequate erosion control measures from nearby residential development and road work. This losing stream contributes water to Fielden Cave, less than 1,400 feet away.

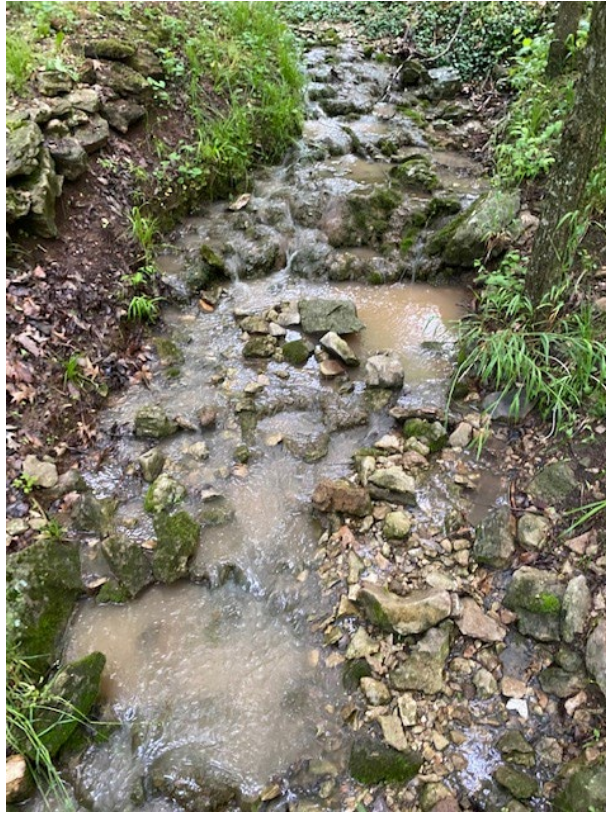
**Figure 31.** Sediment in the Fielden Cave stream after storm flows. At this flow rate the cave stream typically runs clear.
