**Fracture Critical  
Bridge Inspection Report**

**Bridge No. 2490003  
Christian County, Missouri  
Smyrna Road over Finley River**

**Prepared by H.W. Lochner, Inc.  
January 2024**

# Comprehensive Fracture Critical Bridge Inspection Report

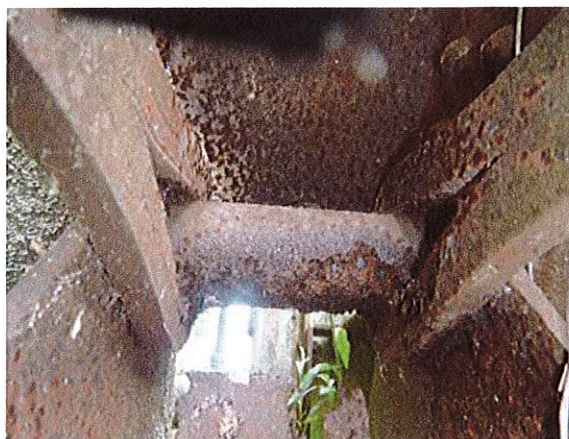
Most of the pins in the lower chord have heavy surface rust but are in fair condition. The pins at L0 on both trusses are in poor condition with 1/8 to 3/16" pitting (**see photo below**).

Thru Truss, West Truss, L0: Pin has 3/16" deep pitting on 1/4 of the pin circumference for 2/3 pin length
