**Fracture Critical  
Bridge Inspection Report**

**Bridge No. 2490003  
Christian County, Missouri  
Smyrna Road over Finley River**

**Prepared by H.W. Lochner, Inc.  
January 2024**

# Comprehensive Fracture Critical Bridge Inspection Report

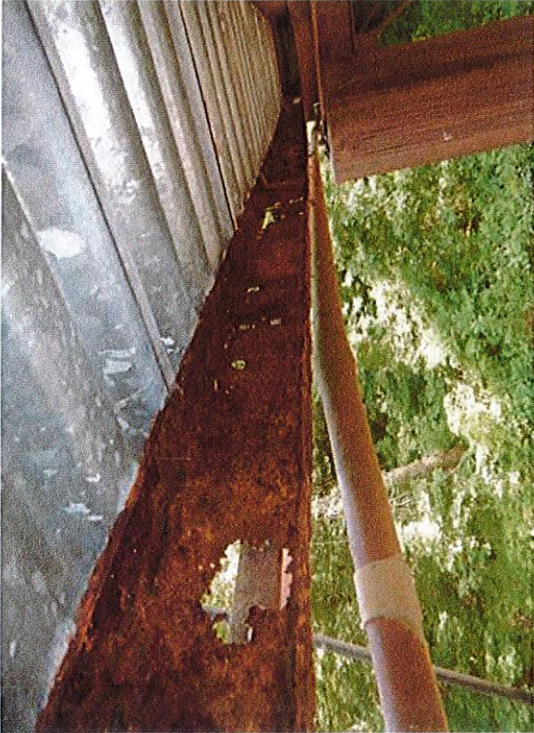
| | PHOTO 41 SPAN 4, PANEL 7, STRINGER 1: Severe section loss in stringer | | |
